## Chapter 13:

# Trail Construction Techniques

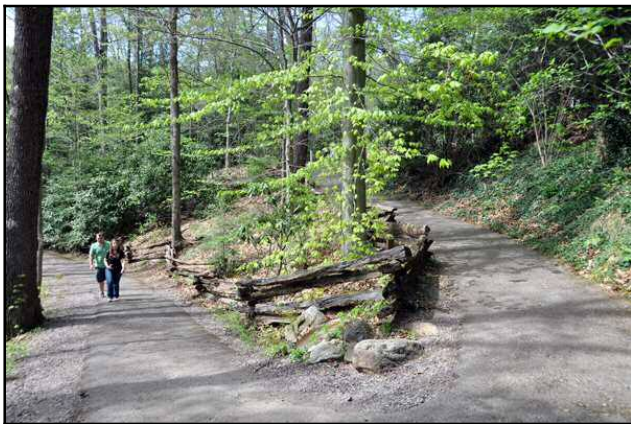
**Figure 13.6: Switchback at Fallingwaters (View #1)** – The switchback creates a gentler slope for the trail. This scene shows the trail switching back on itself to gain vertical elevation without having to use steps. Fallingwaters, Ohio, Pennsylvania. Source: Author – [file:\fw097switchback.jpg]

<c>**Switchbacks** – Another method of reducing the trail gradient by elongating the length of the roadway is the use of switchbacks (Figure 13.6). In a switchback, the trail switches back on itself. In an outdoor setting, a switchback is the normal method of working up a hillside. Creating a spiral is impractical. Like a shoe lace going from one side of the shoe to the other, the trail switches back and forth as it works its way up the hill. Figure 13.6 and Figure 13.7 illustrates a typical switchback from two different views.

Figure 13.6 and Figure 13.7 show considerable elevation change made by the switchback. The alternative to the switchback is a series of steps. The switchback avoids installing steps. However, it consumes considerable real estate.

Last, water runoff needs to be managed. Since the trail in Figure 13.6 has an asphalt roadway, waterbars were not installed to disperse the water runoff off the trail. Regardless, the water still needs to be dispersed. Using the fence to prevent shortcuts is also important for water runoff management. Usually, the water will follow the shortcut and quickly erode the trail and the area in between the switchback even further.

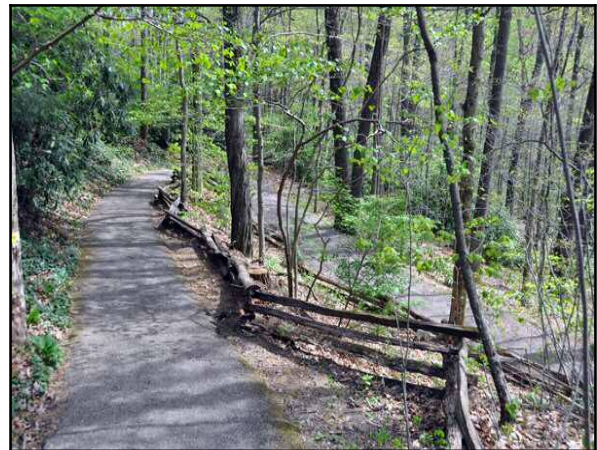
**Figure 13.7: Switchback at Fallingwaters (View #2)** – The switchback creates a gentler slope for the trail. Imagine connecting the upper section of the path and the lower section about 20 yards up the trail. The incline would most likely require steps. Fallingwaters, Ohio, Pennsylvania. Source: Author – [file:\fw096switchback.jpg]

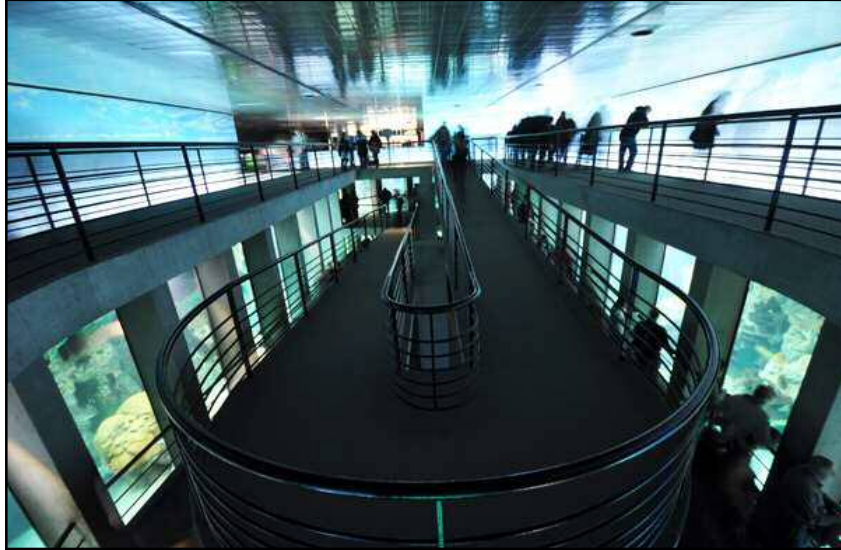
**Figure 13.8: Atlantic Reef Switchback** – Switchbacks can be used internally in buildings. The Atlantic Reef at the National Aquarium is designed like a doughnut where visitors move about in the hole of the donut with the reef surrounding them. The top and bottom levels are level. To get to the spiral walkway on the next lower level, there is a switchback (pictured) in the center of the hole which takes visitors down to the next lower level. In the low light, the walkway makes for safe traversing. National Aquarium, Baltimore, Maryland. Source: Author – [file:\Aquarium030b.jpg]

Although traditionally switchbacks are associated with outdoor trails, they can be used in buildings also. The Atlantic Reef at the National Aquarium is designed like a doughnut where visitors move about in the hole of the donut with the reef surrounding them (Figure 13.8). The top and bottom levels are level. To get to the spiral walkway on the next lower level, there is a switchback (pictured) in the center of the doughnut hole which takes visitors down to the next lower level. In the low light, the walkway makes for relative safe travel.

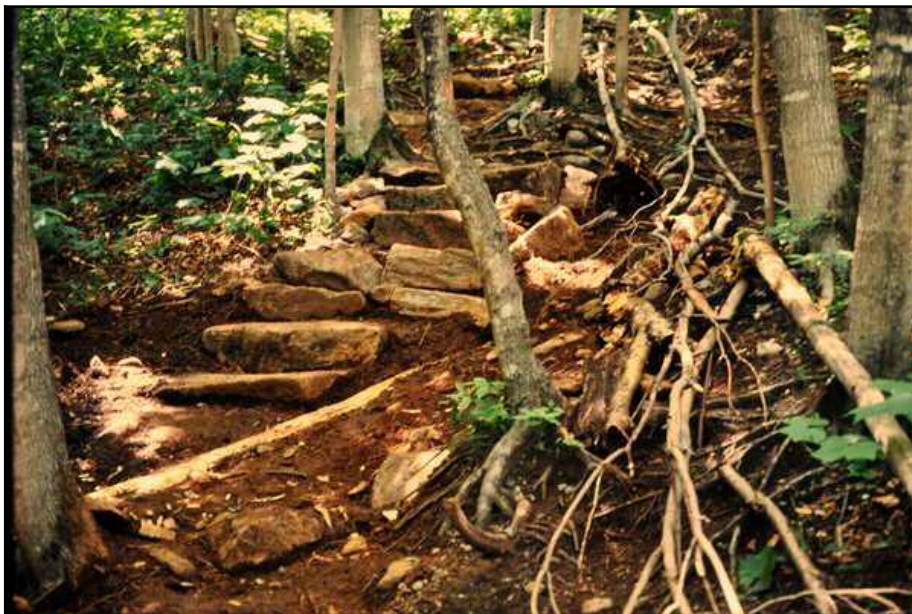
**Figure 13.10: AMC Steps, Waterbars, and Brush** – The AMC (Appalachian Mountain Club) recently completed this trail section. The brush piled on the right encourages the use of the steps and discourages use of the old trail (i.e. where the brush is piled). The waterbar below the steps diverts water off the trail. In two years, this site will look completely natural. Boot Spur, White Mountains. Source: Author – [file:\T905-RockSteps.JPG]

In contrast, the scene in Figure 13.10 is more problematic in terms of containment. Without the stacked brush on the right, the obvious shortcut is to bypass the steps. Close inspection reveals that this is the location of the old trail and the brush is a physical barrier to force people to use the steps. As a sidebar, within two years, the area will become naturalized and the brush will look unobtrusive.

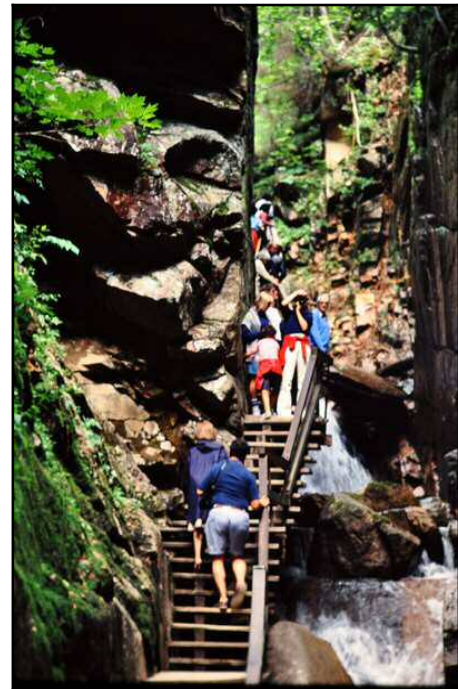
**Figure 13.12: Planked Tread** – The typical plank tread steps are illustrated at the Flume in Franconia Notch. Flume, Franconia Notch, New Hampshire. Source: Author – [file:\fig1255-T317.JPG]

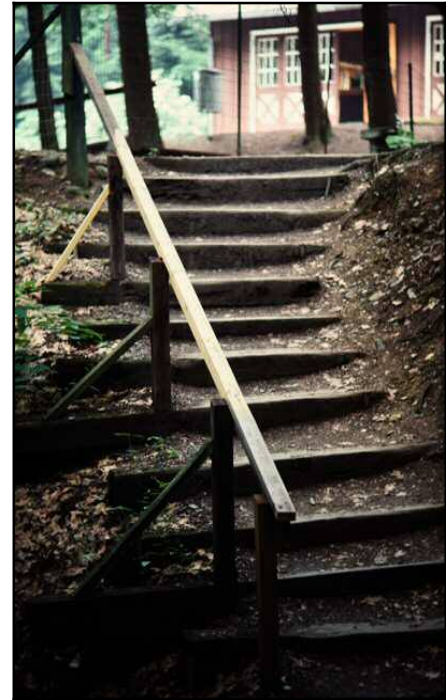
**Figure 13.13: Log or Timber Raiser** – A typical timber raiser steps where railroad ties are used to create the step. The area behind the step is backfilled up to the next step. – Dingman's Ferry, Pennsylvania. Source: Author – [file:\T312-RRsteps.JPG]

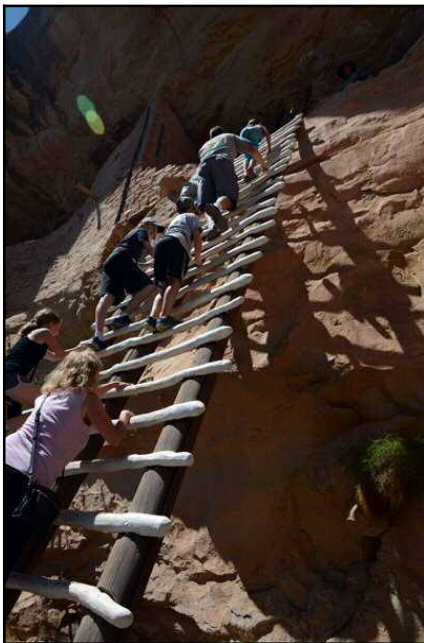
**Figure 13.17: Ladders** – Caption: In Mesa Verde National Park, entrance into the Balcony Cliff Dwelling requires climbing ladders. Mesa Verde National Park, Colorado. Source: Author – [file:\MV129.jpg]

<b>**Ladders** – Ladders are useful when elevation changes are so steep that other alternatives are impractical (Figure 13.17). An advantage of using ladders is that it has minimal impact on the environment. They are not handicapped accessible and even non-handicapped people may be hesitant using ladders. Also, there may be safety considerations. Entrance to the Balcony Cliff Dwelling at Mesa Verde requires climbing several ladders. One of these is shown in Figure 13.17. One woman who was wearing a skirt was momentarily caught off guard. She was thankful that she was wearing underwear the day she visited the Balcony Cliff Dwelling. Such are the issues of interpreters.

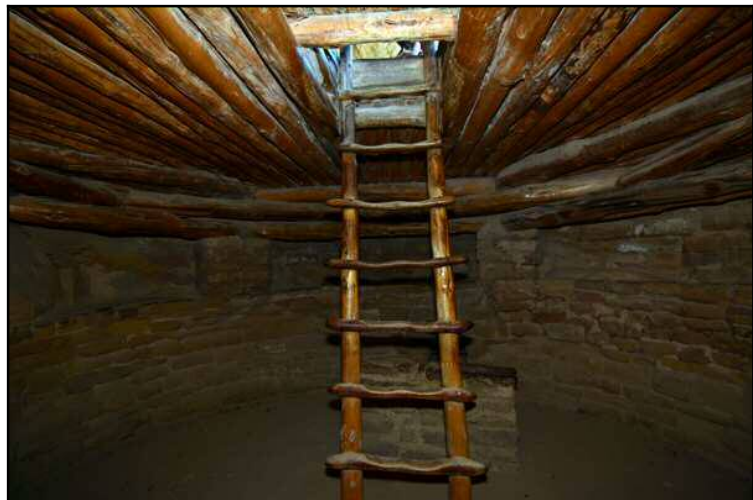
**Figure 13.18: Ladders** – In Mesa Verde National Park, entrance into the reconstructed kiva requires the use of a ladder. The ladder is historical authentic and consistent with the kiva construction. Mesa Verde National Park, Colorado. Source: Author – [file:\MV178[v].jpg]

A second use of ladders is for historical accuracy (Figure 13.18). Entrance into the reconstructed Kiva at Mesa Verde National Park is by ladder. It is historically accurate. It is part of the experience. It would be difficult to create an entrance into the Kiva other than using a ladder which was the original method to enter it. It should be noted that there are numerous exhibits elsewhere that show life in a typical Kiva for those who didn't want to descend the ladder.

From a risk management perspective, look at the wear on the rungs of the ladder. There is noticeable wear. The ladder rungs need to be monitored and replaced before they become breakable under the weight of a visitor on the ladder.

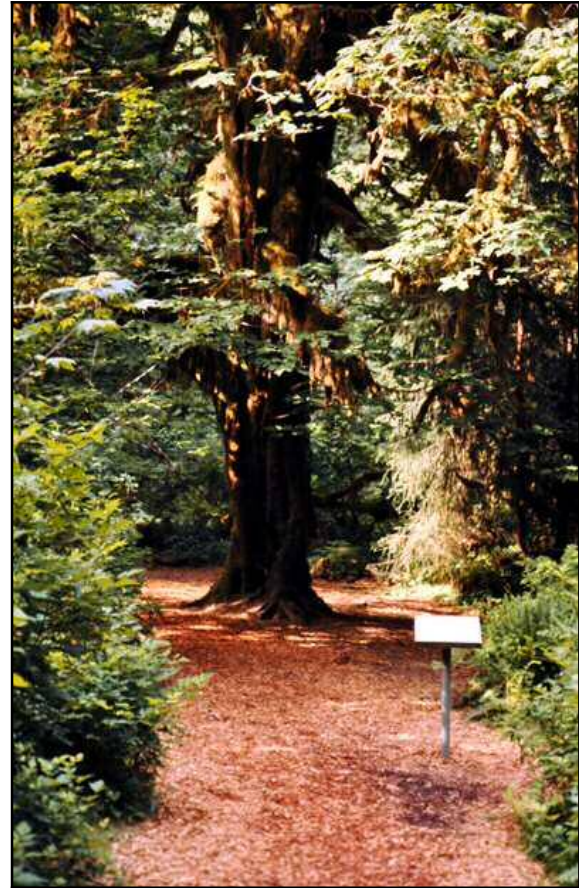
**Figure 13.22: Olympic Trail** – The wood chip trail surfacing provides a clear and obvious trail to follow, and it provides a quiet walkway consistent with the experience. Olympic National Park. Source: Author – [file:\OlympicTrail-S113.jpg] [alt file:\DSC\_0139.JPG]

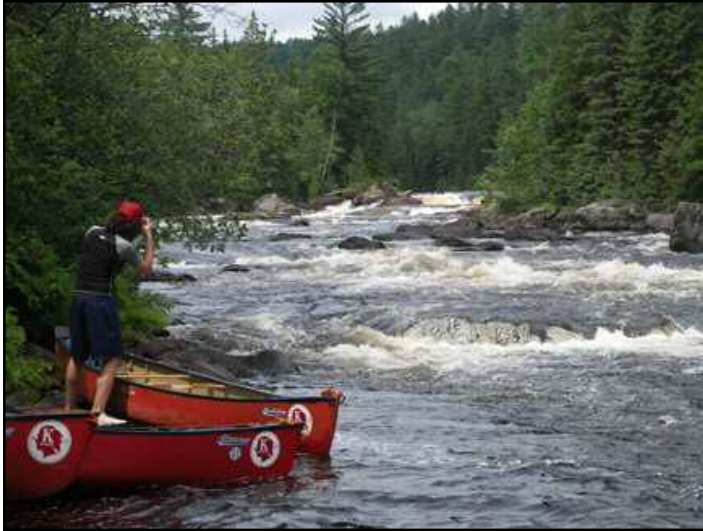
**Figure 13.23: End of the Portage Trail** – Rivers are roadways too. It is the water. Unlike land trails, they can change in difficulty with changes in water levels. Author – [file:\PICT0087.jpg]

Water surfaces can vary greatly. For rivers and whitewater use the International Scale of River Difficulty (AW, 2005). For coastal waters use the ACA Safety Code for Coastal Waters which includes a difficulty scale (ACA, 2007). For the travelers pictured in Figure 13.23, this roadway or stretch of whitewater was portaged by the group. The portage trail is off-scene on the left. The warning sign on the Lehigh river indicates the changing difficulty encountered with different water levels (Figure 13.24).

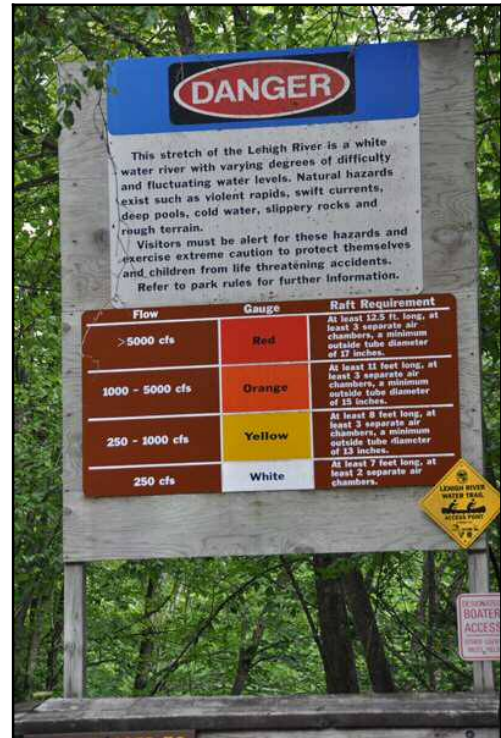
**Figure 13.24: Lehigh River Sign** – This warning sign on the Lehigh River reminds river users on the changing conditions associated with different water levels. The lower sign indicates the size of rafts required for different water levels on the river. Author – [file:\DSC\_0942.JPG]

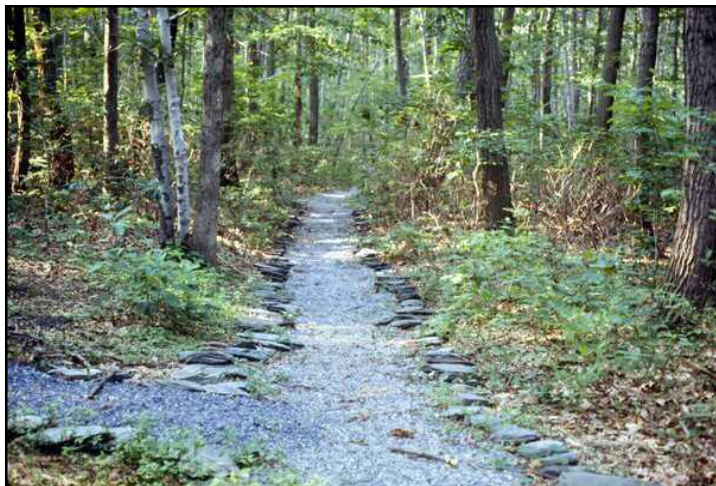
**Figure 13.25: Stone Stringers** – The stone stringers on this trail provide a clear and obvious trail to follow as does the unnatural looking crushed limestone roadway. However, the limestone roadway is noisy under foot. Also, close examination reveals this trail was once a wider dirt road. Although mountain bikers would not be deterred by the thick gravel surface, normal bikes could find this trail surface uncomfortable. Gambrill State Park, Maryland. Source: Author – [file:\DSC\_0137.JPG]

**Surfacing** – Figure 13.2 lists the acceptable and preferred surfacing for each of the activities. There can be considerable overlap in acceptable surfaces listed. A synopsis of surfacing materials is listed in Figure 13.21. To some degree, surface selection can be used to deter use by other user groups. For example, a trail surfacing of loose coarse stone will deter most bike users (excluding mountain bikers) who prefer a smooth asphalt or a surface of packed crusher run stone. However the downside of using a loose coarse stone surface is that it can be noticeably noisier underneath foot traffic (see Figure 13.25).

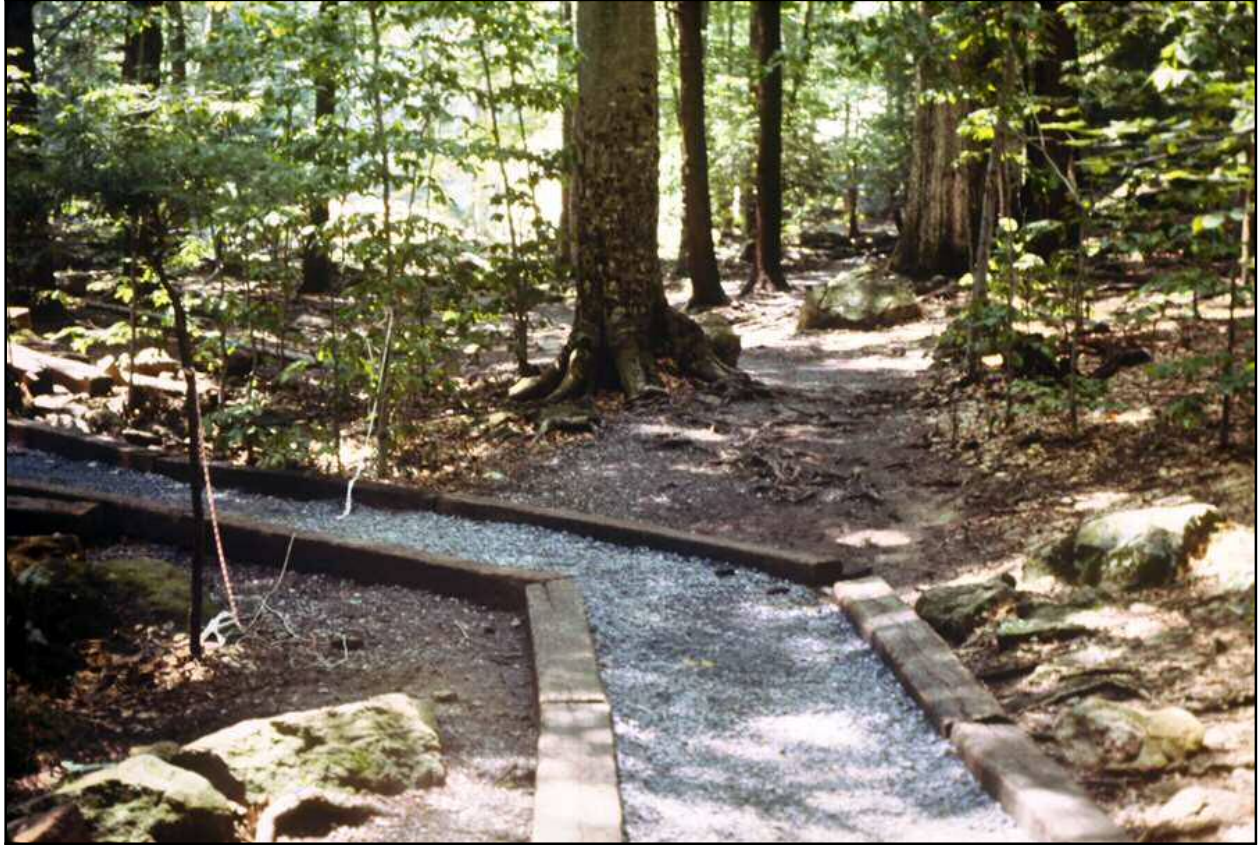
**Figure 13.26: The Old Trail** – The trail is well defined with the limestone surfacing and the railroad tie stringers. The old trail to Cunningham Falls is clearly visible. A fence or naturalization with plants would help deter use of the old trail and short cut. Thurmont, Maryland. Source: Author – [file:\DSC\_0136.JPG]

The trail in Figure 13.26 replaced the old subsoil trail to Cunningham Falls that is still visible in the picture. The stringers are recycled railroad ties and they help to contain the moderately coarse limestone roadway. The trail is well defined and the course of travel is obvious. Given the width of this trail most people will walk single file on the trail.

The old trail is still visible and this poses a potential management problem. The new trail turns left in the picture while the old trail goes straight. The old trail is the shortcut. Unless there is a barrier or unless the historical knowledge of the shortcut can be extinguished, many people will continue to use the shortcut. Close examination reveals that the old trail is a subsoil trail (i.e. the topsoil is missing).

One solution to eliminating the shortcut would be to install a split rail fence on the corner. A physical barrier, people would either need to climb over the fence or walk around it. A second solution would be to naturalize the area. This would provide a psychological barrier since all the cues of the old trail would be erased. Some topsoil would be added to fill in the stretch of subsoil trail. Then some indigenous plants would be added along with leaf litter. Visually, the old trail would look exactly like the surrounding forest. It should be noted that both strategies could be used in conjunction with each other.

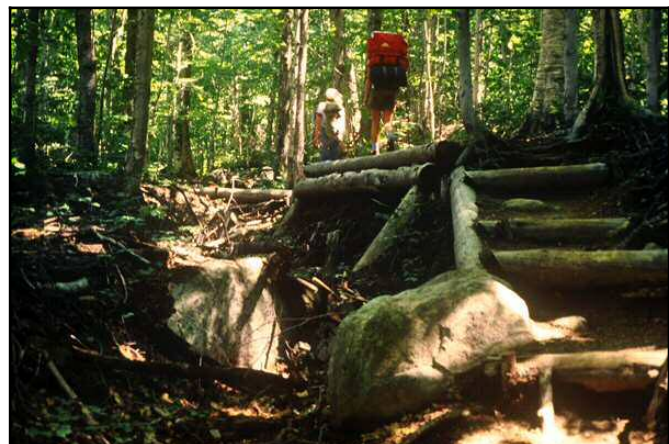
**Figure 13.28: Trail erosion (gully)** – When it rains, trails will often collect the water and become stream-like. The trail has been relocated and the three to four-foot deep gully filled with brush. – White Mountains, New Hampshire. Source: Author – [file:\DSC\_0145.JPG]

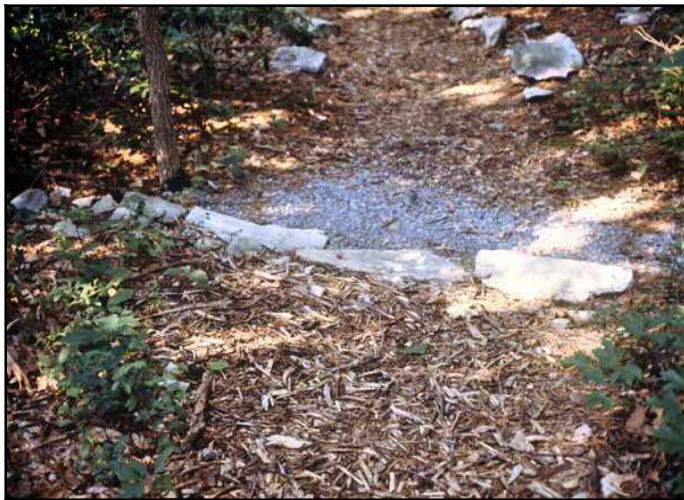
**Figure 13.31: Waterbar (stone)** – An example of a stone waterbar. Note that it utilizes only one row of rocks and an attempt was made to interlock the rocks. The view is looking uphill and the water is diverted to the right in the picture. Gambrill State Park, Maryland. Source: Author – [file:\DSC\_0149.jpg]

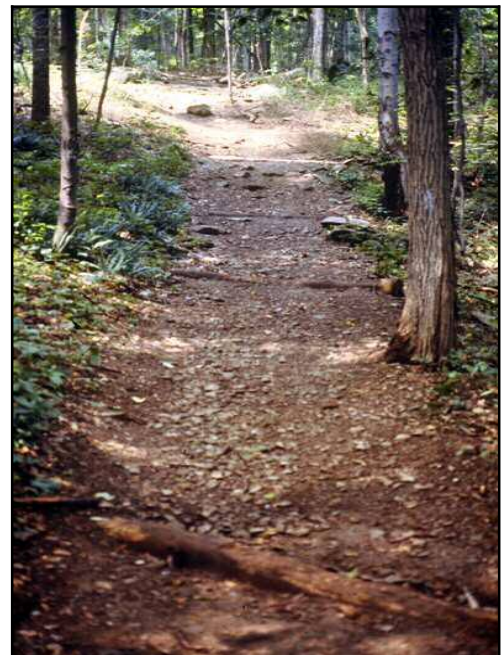
**Figure 13.32: Multiple waterbars** – A series of waterbars placed on the trail to divert water off the trail before it can gain sufficient power to erode the trail. Gambrill State Park, Maryland. – Source: Author – [file:\waterbars.-multi.jpg]

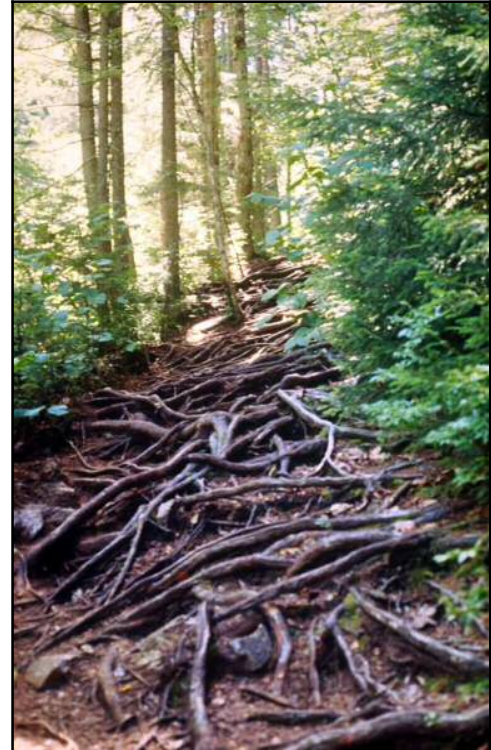
**Figure 13.33: Trail Erosion (Roots)** – Trail users cause compaction and trail erosion leaving exposed roots. White Mountains, New Hampshire. Source: Author – [file:\DSC\_0141.JPG]

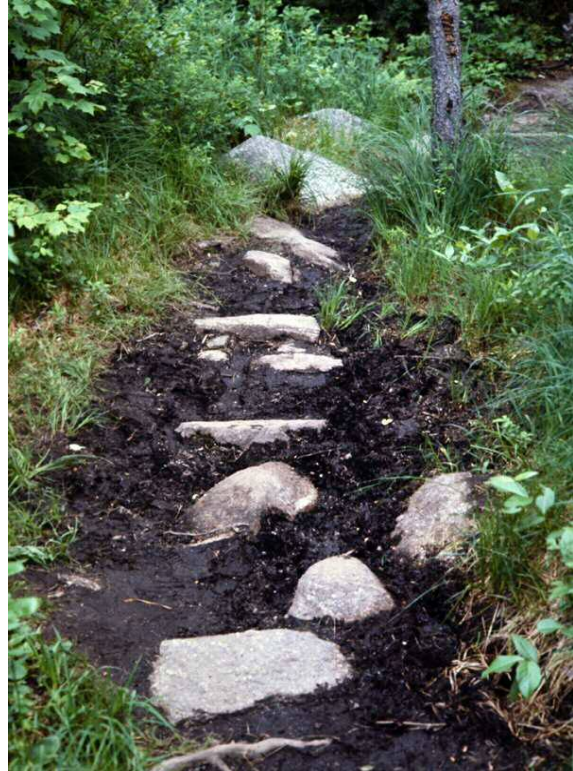
**Figure 13.35: Dieback (stepping stones)** – This is the classic scene showing dieback of vegetation along the trail. People want to avoid walking in the mud and walk on the edge. This creates dieback and mud widens and the process repeats itself. The rock stepping stones are a recent management action that “harden” the site and provide hikers with stepping stones. In time the grass will grow back. Source: Author – [file:\T1419-SteppingStones.JPG]

**Trail Dieback** – Dieback affects other vegetation bordering the trail also. In the backcountry, this is a typical dieback situation where the trail becomes muddy (Figure 13.35). Rather than walking through the mud, hikers walk along the sides trying not to avoid the mud while minimizing their impact to the vegetation. The collective impact compacts the soil creating dieback and an ever widening trail. The stepping stones in the picture are a recent management addition. They harden the site. In time, the grass will grow back and fill in around the rocks. The question to ask is this. Would a typical hiker use the stepping stones or avoid them and hike around the border of the mud? Psychologically, most people will probably find the stepping stones reasonably convenient and use them.

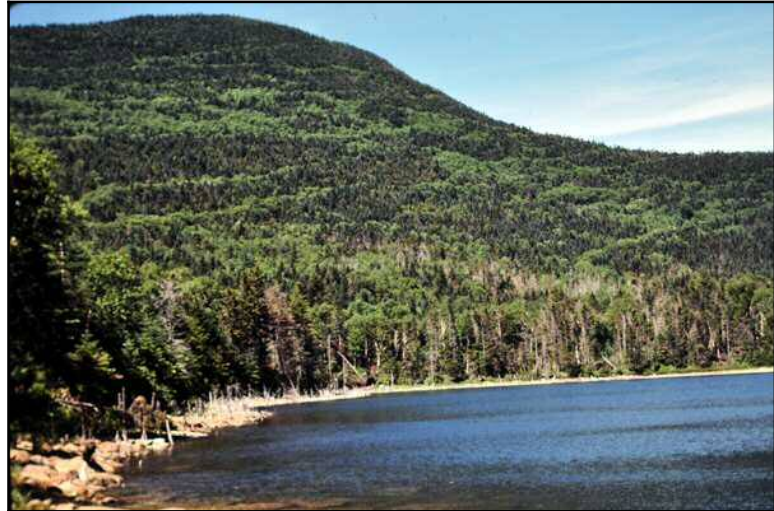
**Figure 13.37: Logging Roads Succession** – To the trained eye, previous land use and impacts can have long term effects. Close inspection reveals abandoned logging roads etched on the side of mountain by non-climax species. The roads are the slightly diagonal lines that are a lighter shade of color. Zeland Pond, New Hampshire. Source: Author – [file:\FW1110-ZelandPondLogging.JPG]

<c>**Succession Impacts** – Trails affect ecosystems. In discussing managing the vertical and overhead planes in Chapter 8, the different examples affected habitat. The closed overhead and open vertical planes are often characteristic of a mature forest where little light penetrates the overhead canopy. The open top encourages an “edge effect” where there is ample light available for vegetation to grow along the trail (see Figure 8.6). The deer in the picture is close to its food source. Trails and abandoned trails can have long term environmental effects. This is clearly evident on the abandoned logging roads next to Zeland Pond (Figure 13.37). The abandoned roads zigzagging up the hillside were filled in with a more evasive species.

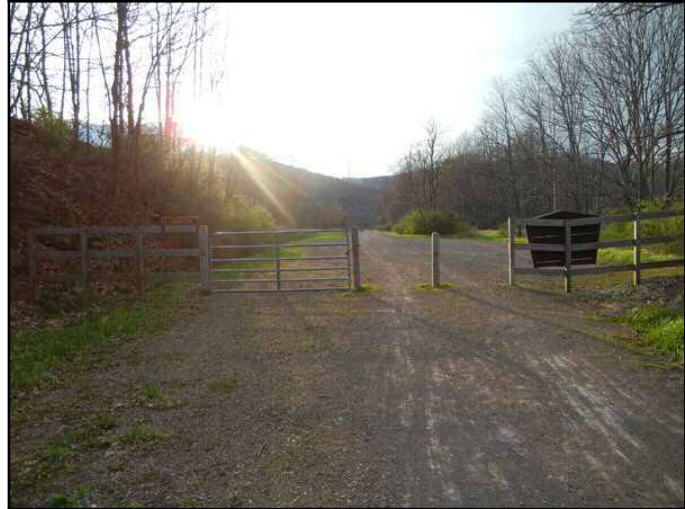
**Figure 13.39: Sandpatch Gate and Bollard** – To provide access, this area utilizes both a removable bollard and gate. Removing the bollard allows access of the rails-to-trail by emergency and maintenance vehicles. Sandpatch, Pennsylvania. Source: Author – [file:\GAP028sandpatch001.jpg]

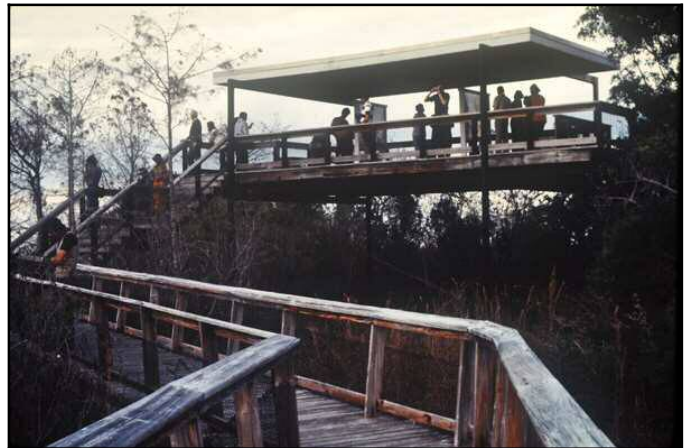
**Figure 13.40: Pa-hay-o-kee Overlook** – Boardwalks enable people to access areas that they otherwise wouldn't be able to access. In addition, it limits or controls access and protects wildlife. Everglades National Park, Florida. Source: Author – [file:\DSC\_0188.JPG]

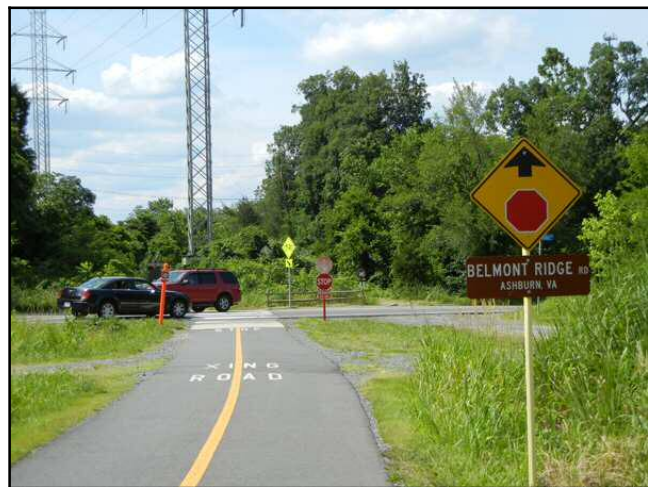
**Figure 13.42: Auto Crossing** – A bridge at this location would avoid conflict between bikers and automobiles. W&OD Trail, Ashburn, Virginia. Source: Author – [file:\W&OD008.jpg]

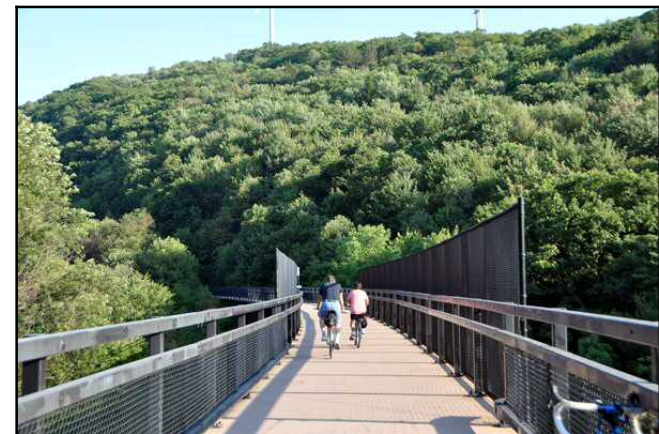
**Figure 13.43: Viaduct** – On the Great Allegheny Passage rails-to-trail, this viaduct crosses a railroad, automobile road, and stream. In doing so, this viaduct avoids three different conflicts. Near Myersdale, Pennsylvania. Source: Author – [file:\GAP029viaduct156.jpg]

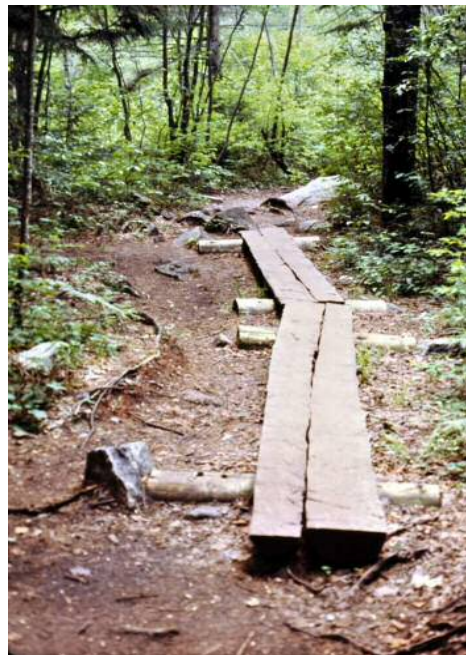
**Figure 13.44: Split log bridge** – This split log bridge protects the fragile duff soil. This area will grow back assuming that hikers use the bridge. Hike this section yourself. Would you use the bridge or the existing compacted trail on the left? Many people would avoid the inconvenience of balancing on the bridge. Perhaps they need to put some brush or rocks to make the trail on the left less convenient. White Mountains, New Hampshire. Source: Author – [file:\T1411-SplitLogBridge[1].jpg]

Although it may not seem like a bridge, the split log bridge in Figure 13.44 provides a bridge across fragile duff soils. When the duff gets wet, it becomes muddy and people walk along the sides to avoid the mud. This compacts the soil, kills the vegetation, and expands the width of the trail. If hikers use the bridge, the vegetation will eventually grow back.

Further illustrating the need to address the psychology of the users using the trail, compare the split log bridge (Figure 13.44) with the stone stepping stones (Figure 13.45). The stepping stones were inserted on the trail to avoid compaction on the trail. As in the previous example, walk this section yourself. Would you find it inconvenient to walk on the stones or to simply avoid them? Most people would probably avoid the stepping stones as an inconvenience. Also, note the exposed roots on the trail and the associated trail erosion.

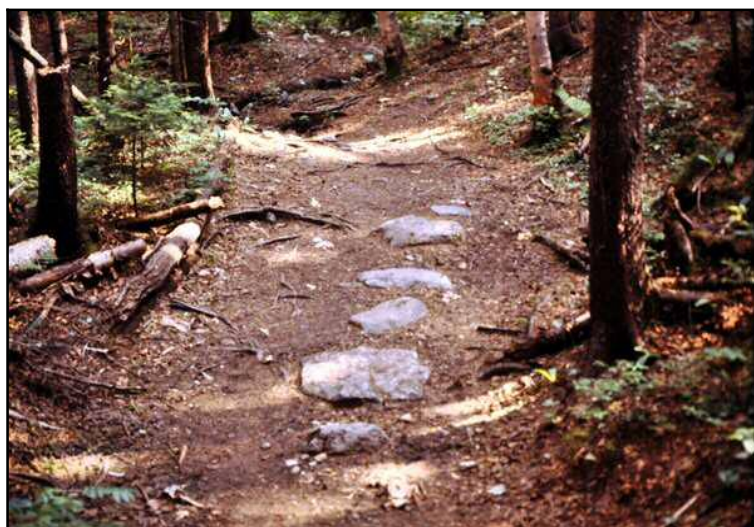
**Figure 13.45: Ineffective Stone Walkway** – This section of the trail demonstrates the improper use of stepping stones on the trail. Most hikers will simply hike on the compacted trail to the left of the rocks and avoid the even slight unevenness of the stepping stones. White Mountains, New Hampshire. Source: Author – [file:\T1410-ImproperSteppingStones.JPG]

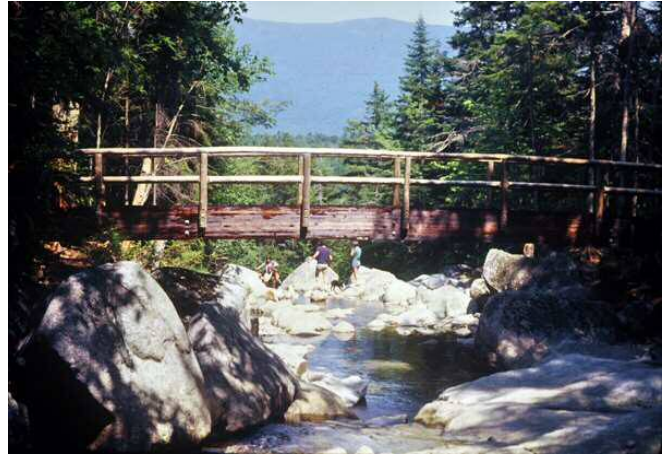
**Figure 13.46: USFS \$50,000 Bridge** – These are three different crossing across the same stream within 100 yards of each other. Although they address the safety issue, they also address the issue of designing the experience. This is the bridge built by the Forest Service for \$50,000. Franconia Notch, New Hampshire. Source: Author – [file:\fig1248-DSC\_0174.JPG]

<b>Experience Provided – When selecting the bridge or boardwalk used, the desired experience should be considered. In the White Mountains, two very different types of bridges occur within 100 yards of each other. The laminate bridge was installed by the Forest Service (Figure 13.46). It is consistent with the bridge specifications offered in the Forest Service Trail Manual (USFS, 1996). One hundred yards up the stream, the State Parks built a rustic log bridge for a fraction of the cost (Figure 13.47). However, consider the experience provided by the two bridges. The aesthetic experience of either bridge can be justified. The State Park’s bridge is more rustic while the Forest Service bridge is a professionally designed bridge that looks like a bridge designed for the purpose of crossing the stream.

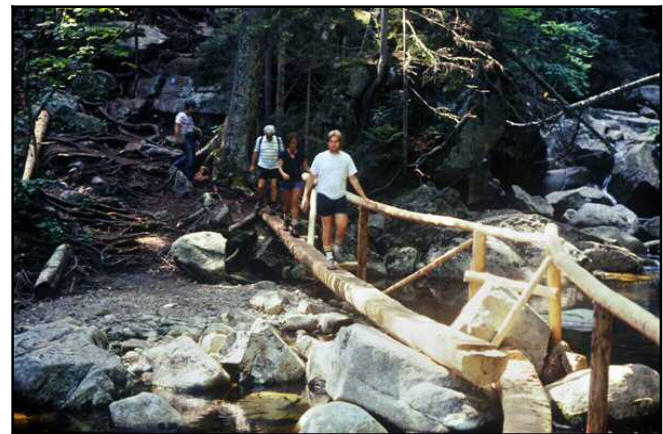
**Figure 13.47: State Park Bridge** – This is the bridge built by the state parks 100 yards up the same stream for \$300. Contrast the experience provide by this bridge with that of the USFS downstream of it. Franconia Notch, New Hampshire. Source: Author – [file:\fig1249-DSC\_0173.JPG]

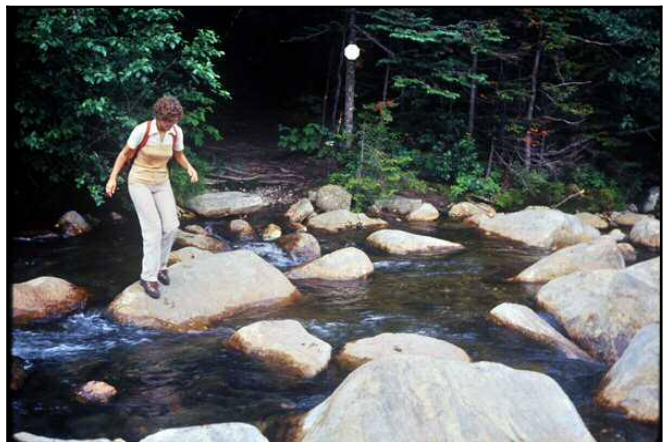
**Figure 13.48: Stepping Stones** – These stepping stones are just upstream of the Forest Service bridge and comprised the normal crossing before the bridge. During high water situations, the stepping stones can be hazardous. Franconia Notch, New Hampshire. Source: Author – [file:\DSC\_0199.JPG]

However, in high water situations, this crossing can become a significant hazard. The normal hazard posed by a high water river crossing is compounded by the sixty-foot waterfall just downstream of the crossing (i.e. where the people are located in the photo). In this context, the bridge addresses a significant safety concern.

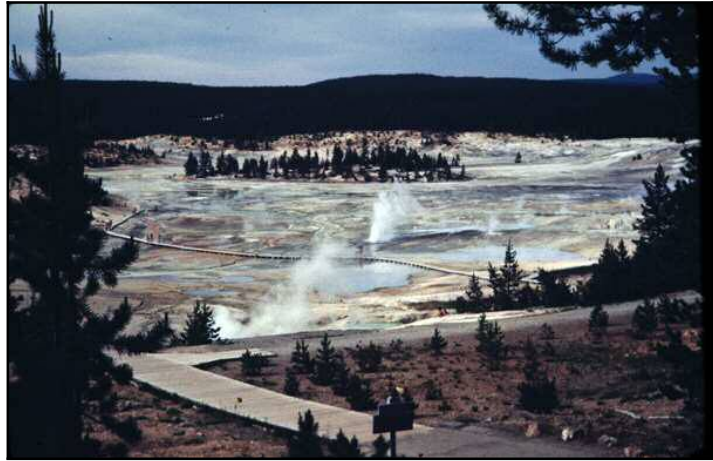
**Figure 13.49: Yellowstone Boardwalk** – This is a low level boardwalk traversing the hot springs at Yellowstone National Park. Notice how the walkway harmonizes with the landscape. However, since there are no railings, some would raise a safety concern. Yellowstone National Park, Wyoming. Source: Author – [file:\T1017-DSC\_0189.JPG]

Caution needs to be expressed that the bridge or boardwalk does not itself create a hazard. Consider the boardwalk over the hot springs at Yellowstone Park (Figure 13.49). The hot springs are deep pools of scalding hot water. The boardwalk without railings is aesthetically pleasing and visually less obtrusive. It harmonizes with the landscape. However, the lack of railings poses a potential safety issue.

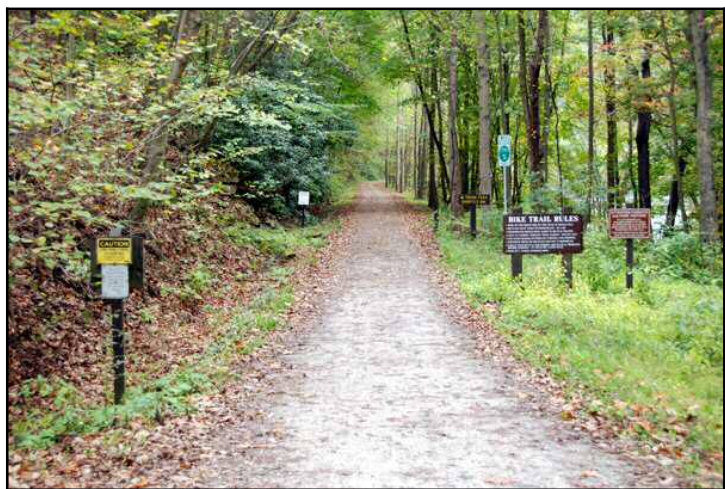
**Figure 13.50: Trail Entrance** – This is one of many public access point on the Great Allegheny Passage Trail. It shows the locations of the signs providing information and rules found on Figure 13.51 through Figure 13.53. Great Allegheny Passage Trail, Near Confluence, Pennsylvania. Source: Author – [file:\mct-sign10-general.pdf]

<b>*Trail Head* – Several Figures show a typical ensemble of signs at a public entrance point on a rail-to-trail. Figure 13.50 provides a photo of the overall scene at the trail entrance. Its purpose is to provide orientation. The sign on the left deals with hunters. One sign in the background gives the mileage to the next major trail head, and the other sign indicates that this trail is part of a bike route. In the foreground are two rules signs (Figure 13.51 and Figure 13.52).

<c>**Critical Junctions** – Using the critical junction approach, trail signs are placed at the critical junctions along the trail (Figure 13.54). Usually, these critical junctions are at places where the trail branches. Trail heads are critical junctions. The signs in Figure 13.50 are located at a trail head.

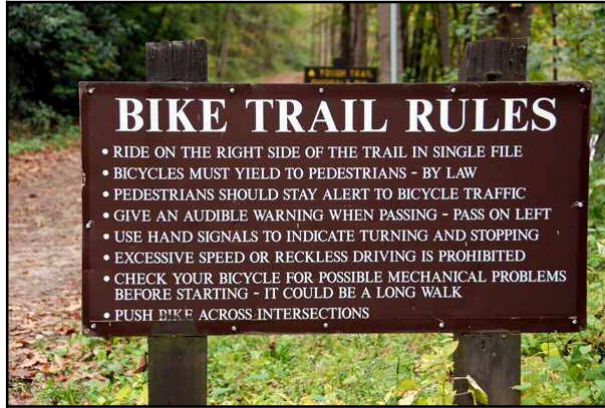
**Figure 13.51: Bike Trail Rules** – This is closeup photo of the bike trail rules. The rules are brief. They cover riding etiquette and things that are prohibited. Great Alleghany Passage Trail, Near Confluence, Pennsylvania. Source: Author– [file:\rmct-sign11.pdf]

The first sign of rules is the standard sign found at most major entrance locations (Figure 13.51). The sign assumes that the primary purpose of the trail is as a bike trail. Although some trail heads have equal amounts of joggers and people strolling as bikers, the trail is designed primarily as a bike trail. The sign presents a series of bullet points delineating for the most part trail etiquette such as “pass on left” and stay

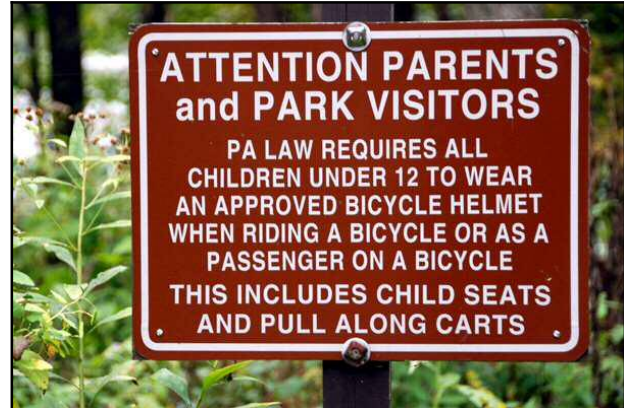
**Figure 13.52: More Rules Sign** – This figure shows the closeup photo of the other rules sign. Great Alleghany Passage Trail, Near Confluence, Pennsylvania. Source: Author– [file:\rmct-sign12.pdf]

alert for other user groups. As a footnote, “excessive speed or reckless driving” is not defined and has an automobile connotation. The second rule sign focuses on the helmet law as it applies to children (Figure 13.52).

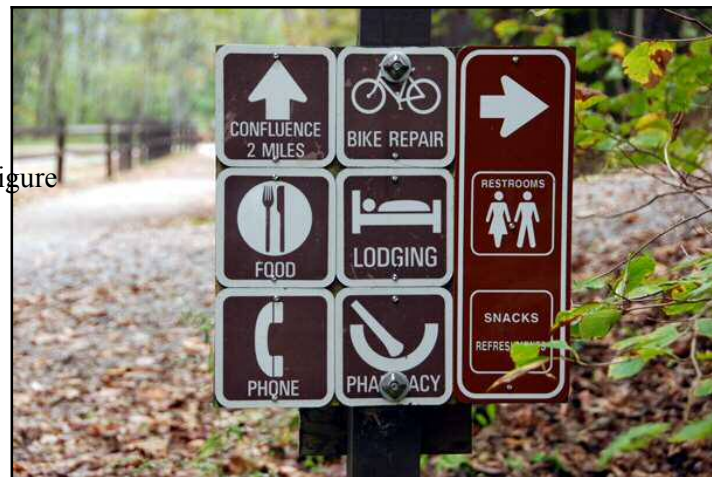
**Figure 13.53 – Information Signs** – This figure shows a closeup of an information sign. It provides directions and services Great Alleghany Passage Trail, Near Confluence, Pennsylvania – Source: Author– [file:\rmct-sign13.pdf]

An informational sign (Figure 13.53) is out of sight of the trail entrance photo (Figure 13.52). It faces incoming traffic. The sign uses standardized icons as modules that are assembled together on the sign. They provide directions and services available onsite and at the next town.

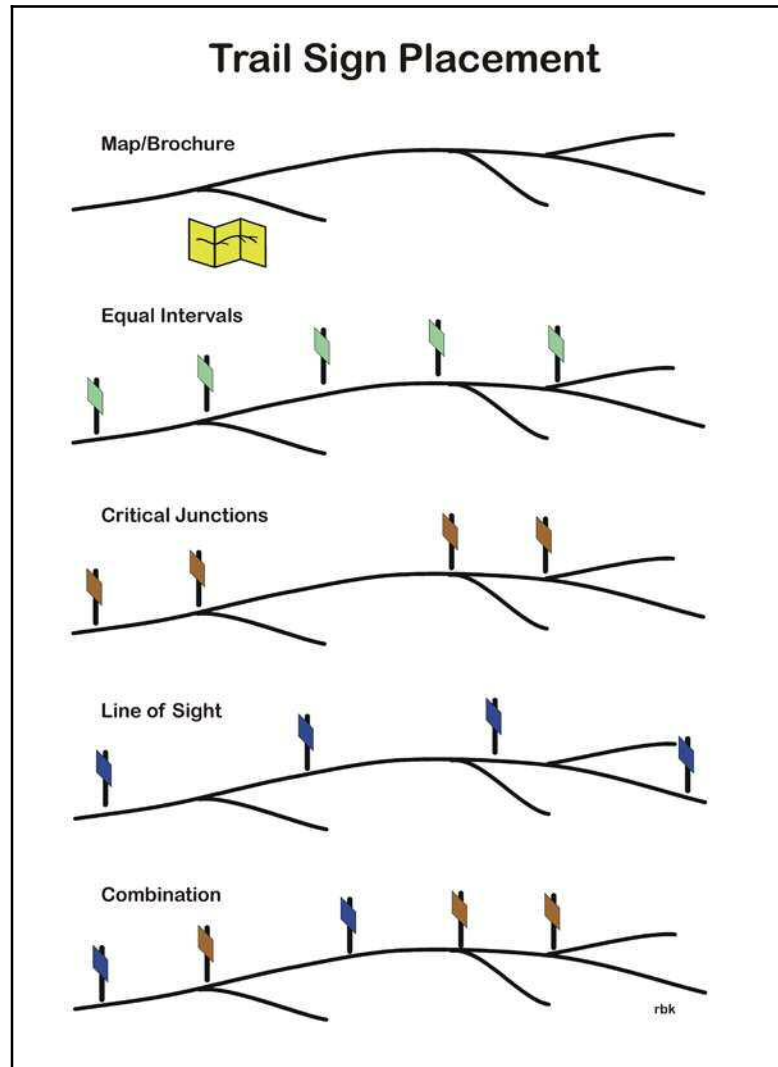
**Figure 13.54: Trail Sign Placement** – This figure shows the different trail sign placement configurations. – Source: Author– [file:\TrailSignPlacement.pdf]

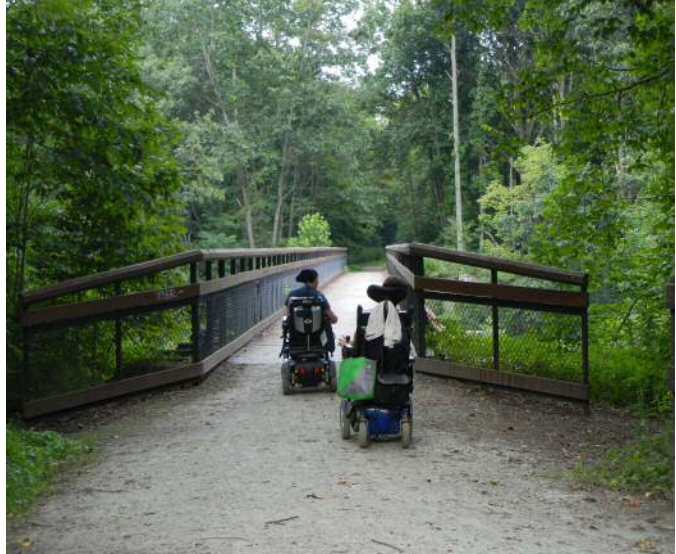
This rail-to-trails easily accommodates these power wheel chair adventurers without additional modifications. Consider that they run in pairs in case of a breakdown. Also, they are out of cell phone communication if there is a problem. This is a true adventure for them. Near Markleton, Pennsylvania. Source: author – [file:\GAP051trail023.jpg]

An example of universal design is Greater Allegheny Passage (GAP) trail. The proper design of the trail for bicycles makes the trail equally accessible to other users, including powered wheel chairs (Figure 20.14). Care needs to be taken with the parking lots and access to the trail to remove barriers. The two adventurers pictured in Figure 13.55 traveled a remote six-mile stretch on the GAP trail. They traveled in pairs for safety reasons. There is no cell phone connectivity. They need to plan for mechanical problems, battery issues, shuttle and blow-downs, and other problems they can encounter along the trail. These problems are a variation of the problems faced by a normal biker.

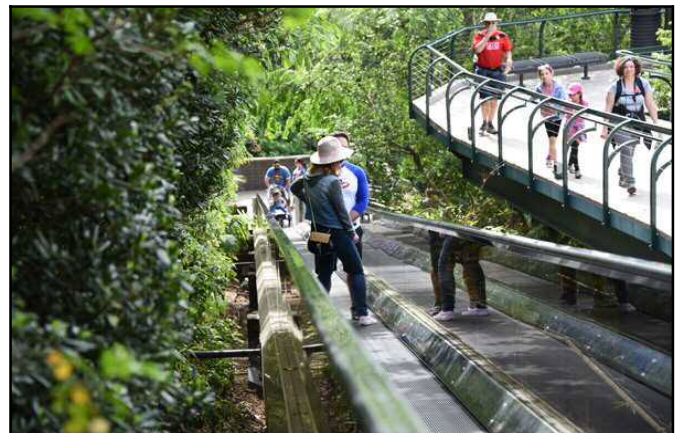
**Figure 13.56: Strollers, Escalators and Switchbacks –** Strollers face many of the same issues as handicapped accessibility. At the San Diego Zoo, an escalator helps provide accessibility in a park with significant elevation differences. A stroller is pictured on the lower portion of the escalator. An alternative to the escalator is a walkway consisting of a series of switchbacks. San Diego, California. Source: author – [file:\SDZ051escalator[gd].JPG]

Most people associate universal design and handicapped accessibility with handicapped. This need not be the case. On a typical Saturday and Sunday, the San Diego Zoo is inundated by young parents pushing baby strollers. The strollers face many of the similar problems associated with handicapped accessibility. Presenting an additional challenge, there are significant elevation differences within the park. Helping to address this situation, the park installed an escalator to move people and strollers from the lower levels in the park back to a higher elevation (Figure 13.56). For those not choosing to use the escalator, the park has a typical

switchback walkway in close proximity to the escalator. There is universal access throughout the park.

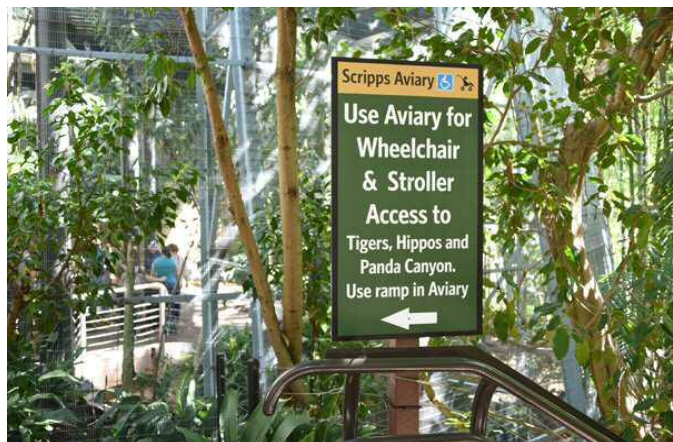
**Figure 13.57: Retrofitting for Strollers and Wheelchairs –**

The sign suggests an alternative route around a steep series of steps. In addition, the sign reinforces the premise of universal design that strollers face many of the same accessibility issues as wheelchairs. San Diego Zoo, California. Source: author – [file:\SDZ019.JPG]

Sometimes simple planning can provide universal access without extensive retrofitting (Figure 13.57). To the right of the sign in Figure 13.57 is a steep series of steps that provide a barrier to strollers and wheelchairs. In this case, the path through the aviary provides accessibility or a path to the lower level. In addition, the sign reinforces an underlying premise of universal design that there is not much difference between the accessibility needs of strollers and wheelchairs.
