## Chapter 14

# Historic Preservation

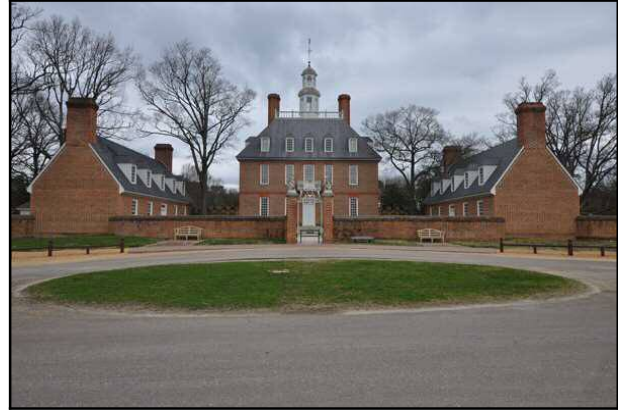
**Figure 14.2 – Governor's Palace** – Caption: The Governor's Palace in Historic Williamsburg is an example of preservation or what was originally there. – Source: author [file:\fig1302-WB062.JPG]

basement. Once it was reconstructed, the Governor's Palace is in need of preservation and maintenance to maintain it (figure 14.2).

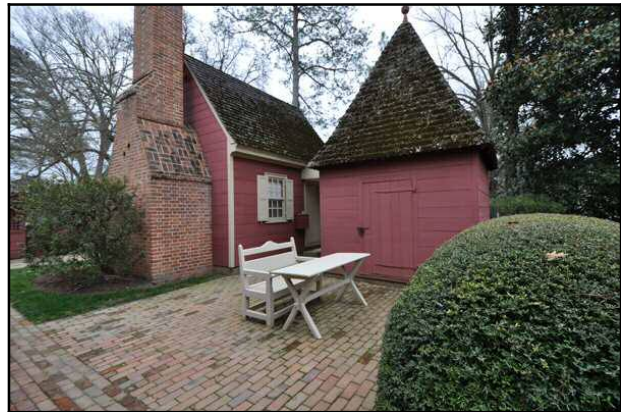
**Figure 14.3 – Outbuildings** – Caption: Traditionally, outbuildings are not constructed with longevity in mind. Examination of these two outbuilding next to the Wyrth house reveals that they are not built on substantial foundations and that the wood shingles are moss covered and will soon need replacement. – Source: Author [file:\fig1303-WB036.jpg]

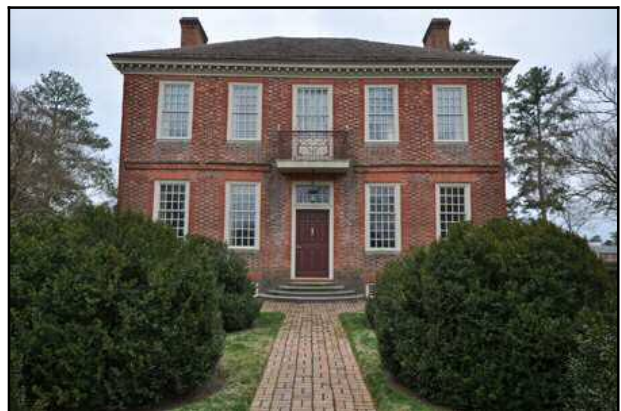
**Figure 14.4 – Lightfoot House** – Caption: The Lightfoot House is an example of a building that for the most part needs preservation. – Source: author [file:\fig1304-WB037.JPG]

In Williamsburg, the Lightfoot House is an example of a restoration that was predominately preservation oriented (figure 14.4). Building are lived in and they change with the amenities available during the time period. A building fixed in time is most likely a building purposely being preserved.

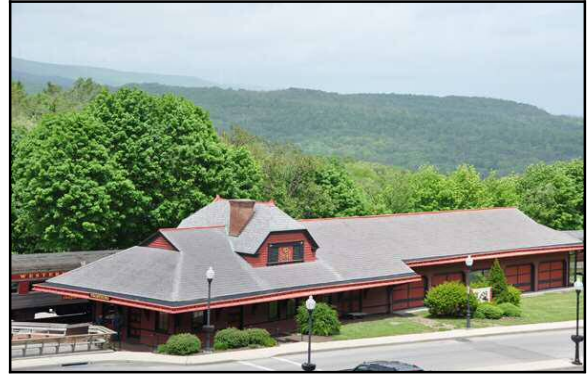
**Figure 14.5 – Depot** – Caption: The Depot was originally a railroad depot. Maintaining its historical integrity, the building was adapted into a restaurant. This creates an economic use and benefit for the community while maintaining the basic integrity of the resource. – Source: author [file:\fig1305-HP98-Depot.JPG]

The Depot was a railroad depot on the Western Maryland Railroad (figure 14.5). It is a typical railroad depot on the railroad line. The railroad went bankrupt in the 1970s and this segment of the railroad eventually became a scenic steam powered railroad. The terminus is at the Depot. Using grant funds, the Depot was refurbished and was a highly successfully and very popular restaurant for numerous years. Close inspection of the photo reveals the glass enclosure of what was once an open deck area on the railroad depot. The basic historic integrity of the structure was maintained and its economic viability helped to insure the maintenance and upkeep of the historic structure.

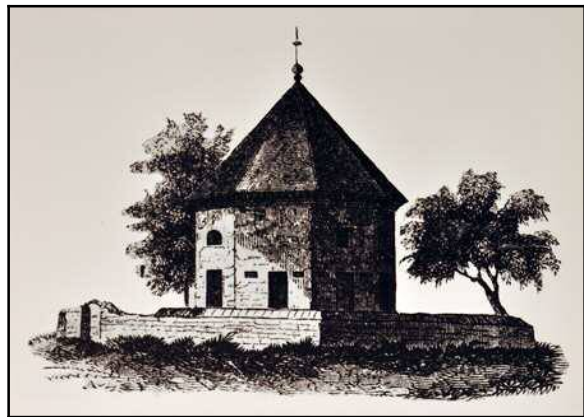
**Figure 14.6 – Magazine (original)** – Caption: – An original sketch of the Magazine at Williamsburg provides a good guide in the restoration of the building. – Source: Yetter, G., (1988) [file:\fig1304-WB105.jpg]

The Magazine at Williamsburg, Virginia provides a good example of the restoration process. Portions of the building were missing or in the need of repair. The building was built in 1715. The plate of the Magazine was made circa 1850 (figure 14.6). The wall around the Magazine was built circa 1758 and demolished in 1856. The building was used as a livery stable and it remained in fairly good shape at the turn of the last century (1900). The building was used as a Greek Revival Baptist Church and figure 14.7 shows the Magazine prior to its restoration in 1934. The sketch in figure 14.6 provides a good depiction of the period and condition to which the Magazine will be restored. The restoration of the Magazine today (circa 2013) is fairly close to the sketch (figure 14.8).

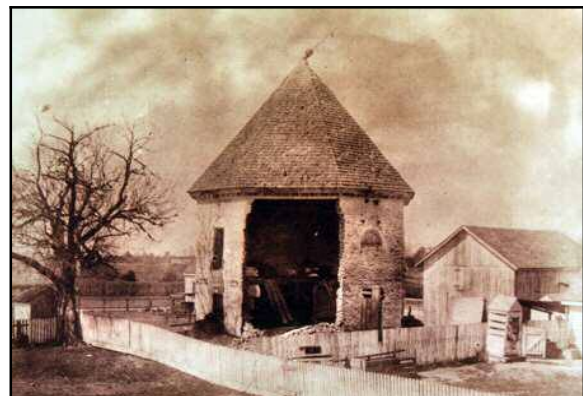
**Figure 14.7 – Magazine (before restoration)** – Caption: The Magazine before restoration. A portion of the wall of the Magazine is missing as is the wall surrounding the Magazine. – An original sketch of the Magazine at Williamsburg provides a good guide in the restoration of the building. – Source: Yetter, G., (1988) [file:\fig1305-WB106.jpg]

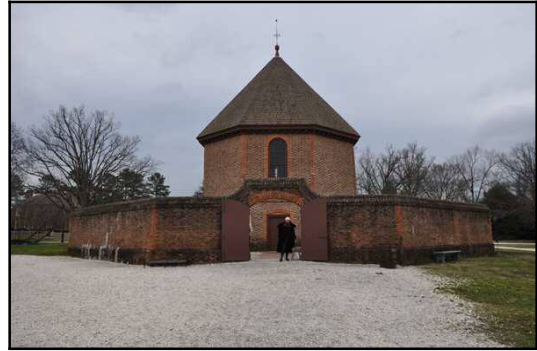
**Figure 14.8 – Magazine (2013)** – Caption: – The Magazine today after restoration (2013). – Source: Author [file:\fig1308-WB044.JPG]

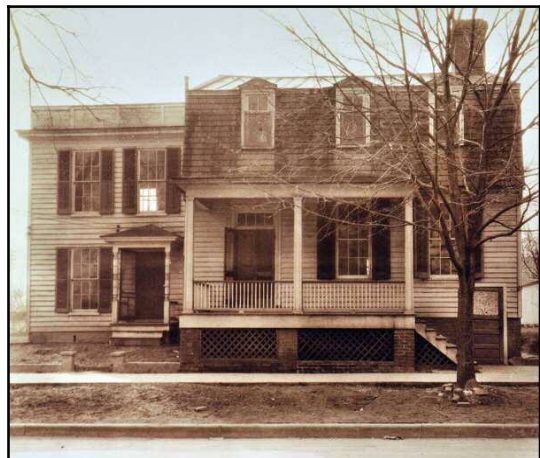
**Figure 14.9 – William Lightfoot House (before)** – Caption: – Buildings change over time. With the New Federalism addition on the left, the William Lightfoot house (Orrell house) was inconsistent with the period. The addition was razed. Compare the changes in the house (e.g. windows, doors, porch, sidewalk, etc.). – Source: Yetter, G., (1988) [file:\fig1309-WB108.jpg]

The second form of restoration is the elimination or removal of portions of a structure to bring the structure into conformity with the designated time period. In the restoration of Williamsburg, Virginia, the William Lightfoot House illustrates this strategy. Figure 14.9 shows the building in 1929. The wing on the left was most likely built before 1846 and the porch with its balusters were most likely added in the nineteenth century. The same is for the cellar door added on the right corner of the building next to the steps.

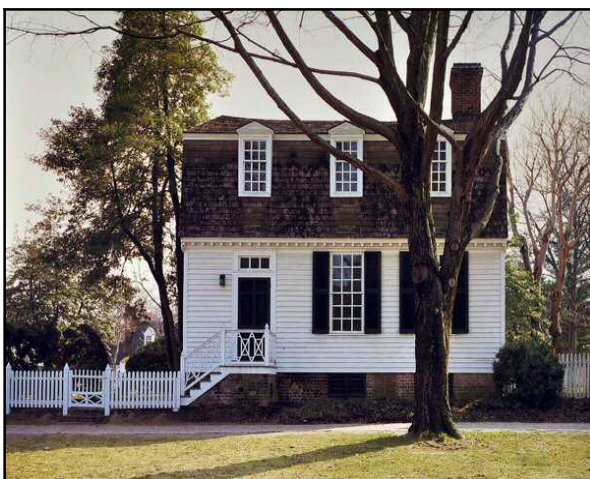
**Figure 14.10 – William Lightfoot House (before)** – Caption: As depicted in the Yetter book, this photo is of the restored William Lightfoot (Orrell) house circa 1988 after restoration. Compare it with the original structure (figure 14.9) and the house generally identified as the Orrell house (figure 14.11). – Source: Yetter, G., (1988) [file:\fig13010-WB107.jpg]

In 1931, the Lightfoot house was restored to its appropriate period (figure 14.10). The restoration was extensive. The wing of the house on the left and the porch were removed. Removing the cellar door was no easy task and illustrates the difficulty of restoration. The missing bricks in the foundation needed replacement. The bricks could be made onsite or salvaged from other structures. Not only did the bricks need to match the original, but the mortar needs to match the rest of the foundation. In terms of the restoration, the mortar is most likely more critical since a different color mortar will attract the eye of viewers (it is white). Next, the siding needs to be replaced and the lengths of the siding need to be varied and worked into the original siding so as not to look like an obvious patch job.

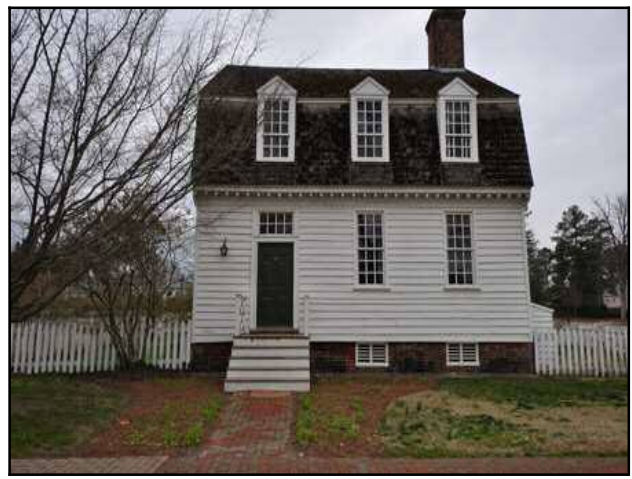
**Figure 14.11 – Orrell House William (after)** – Caption: Decide for yourself if the William Lightfoot House identified in Yetter's book is really the Orrell House. This photo was taken in 2014. Examine the size, roof, windows, doors, spatial relationship of the doors and windows to each other, dormers, and chimney to determine if they are most likely the same house. If they are, building can change a lot within twenty years (Note the sidewalk also). – Source: author [file:\fig1311-WB030.JPG]

house or sent the author to the Orrell house. So decide for yourself if the William Lightfoot House identified in Yetter's book is really the Orrell House (figure 14.11). The Orrell house photo was taken in 2013. Examine its size, roof, cornices, windows, doors, spatial relationship of the doors and windows to each other, dormers, and chimney to determine if they are most likely the same house. Also, there is room on the left of the house for the addition razed. In contrast, note the changes to the sidewalk. If they are the same buildings, the buildings can change a lot from 1929 to 1931 and again to 2013.

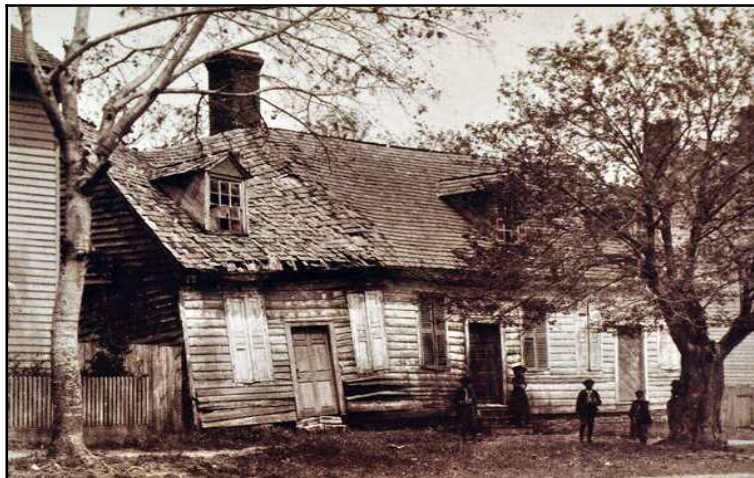
**Figure 14.12 – John Crump House (before)** – Caption: In Williamsburg, the John Crump House was razed in 1893. Since it is located on the Duke of Gloucester Street along with other establishments, it was important to reconstruct the house to be consistent with other buildings. It was reconstructed in 1941 (figure 14.11). The original photo provided important source material for the reconstruction. Note that a tree was planted where there was originally a tree in the photo – Source: Yetter, G., (1988) [file:\fig1310-WB109.jpg]

The John Crump House was razed in 1893. Figure 14.12 shows the building in disrepair before being razed. Since it is located on the Duke of Gloucester Street along with other establishments, it was important to reconstruct the house to be consistent with other buildings. It was reconstructed in 1941 (figure 14.13). The original photo provided important source material for the reconstruction. Note that a tree was planted where there was originally a tree in the photo.

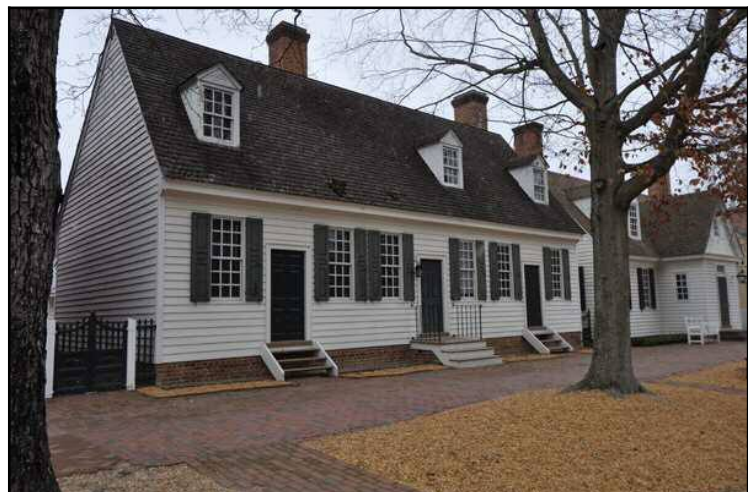
**Figure 14.13 – John Crump House (after)** – Caption: This is the John Crump house in 1941 after it was reconstructed. The original photo provided important source material for the reconstruction. Note that they planted a tree where there was a tree in the photo also. – Source: Author [file:\fig1311-WB097.JPG]

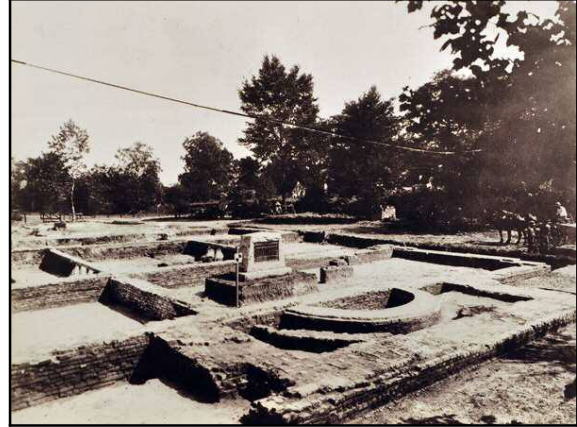
**Figure 14.14 – Archaeological excavation of Capital site** – Caption: Although this excavation was in preparation for the reconstruction, it would be totally appropriate to identify and interpret the foundations only. This would save considerable monies in terms of reconstruction and maintenance. – Source: Yetter, G., (1988, p.76) [file:\fig1314-WB104.jpg]

Archaeological excavations were performed of the site of the Capital in 1928 (figure 14.16). From an interpretive perspective, the site could have been stabilized and interpretive signage indicating the nature and scope of the Capital could be provided to visitors. The foundation would help visitors visualize the dimensionality of the Capital as well as provide interest to visitors itself. This level of interpretation would be relatively inexpensive.

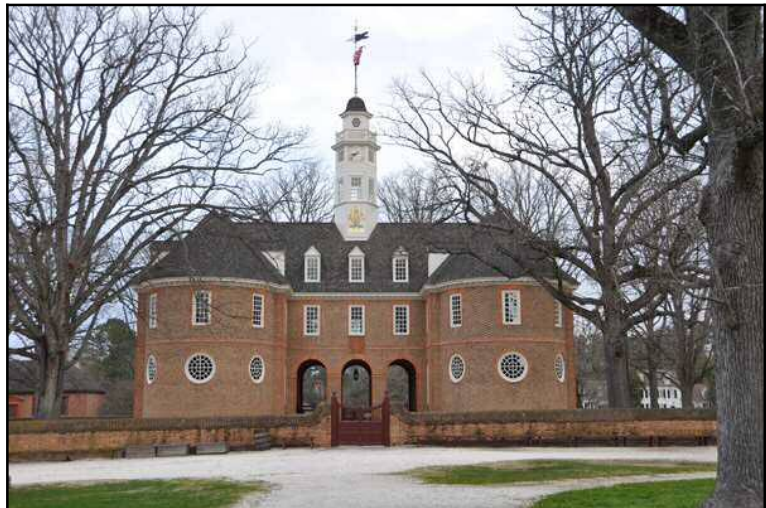
**Figure 14.16 – Capital building** – The Capital was totally reconstructed in 1932-1933. – Source: author [file:\fig1316-WB003-capital[gd].JPG]

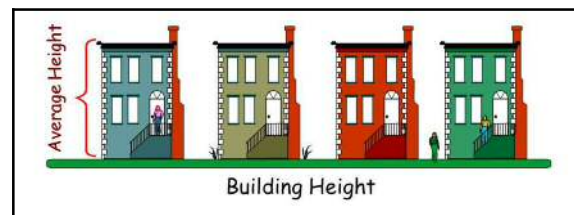
**Figure 14.18 – Height** – Caption: Height is one factor used to determine conformity within a historic district. – Source: Author [file:\fig1318-Height.jpg]

– The height of buildings or the number of floors is determined by the construction materials and amenities required in the building. Generally, any building over three floors requires an elevator. The extra cost of the elevator becomes a limiting factor on the height of buildings. Also, taller building require steel construction which is more expensive than masonry construction. Hence the height of prevailing structures becomes a factor in determining conformity among buildings in a community (figure 14.18).

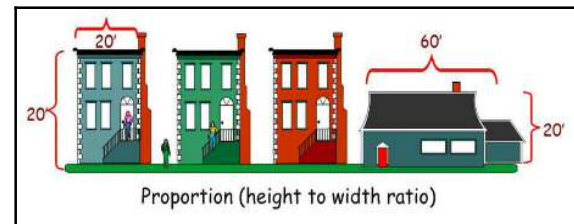
**Figure 14.19 – Proportion** – Caption: Proportion is the ratio of the building's height to width. – Source: Author [file:\fig1319-Proportion.jpg]

– Proportion is the height to width ratio. Generally, if the height remains constant within a neighborhood, the width will be also be determined by the height. Figure 14.19 demonstrates this principle. The building on the right is not in proportion to the other building in the neighborhood.

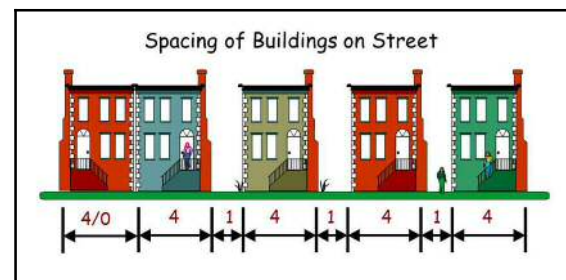
**Figure 14.20 – Spacing** – Caption: Spacing between buildings is an important consideration in historic preservation – Source: Author [file:\fig1320-Spacing.jpg]

– Normally, when a parcel of land is subdivided into building lots, the size of the lots are fairly uniform. In addition, the building code for the community usually dictates the minimum distance that the building can be built to each of the boundary lines. This will establish a spacing between the buildings along the street (figure 14.20). Also, it establishes a rhythm. The two buildings on the left has a different spacing between building in comparison to the other buildings on the street.

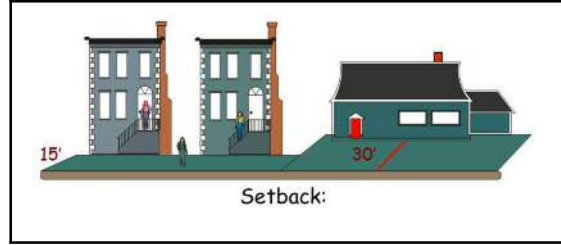
**Figure 14.21 – Setback** – Caption: Setback is the minimum distance that the building must be “set back” from the street. – Source: Author [file:\fig1321-Setback.jpg]

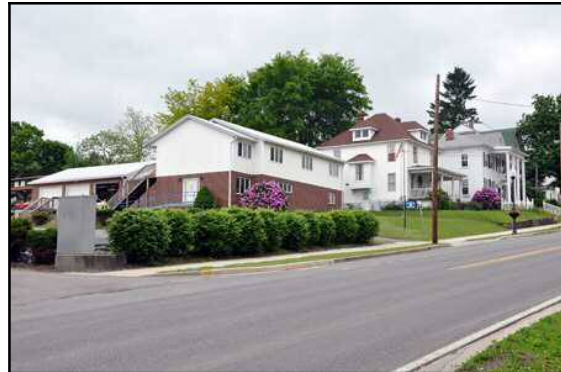
**Figure 14.22 – Frostburg Ambulance** – Caption: Located in a historic district, it shows improper setback, proportion and a facade that is inconsistent with the surrounding buildings. Frostburg, Maryland. – Source: Author [file:\fig1322-HP25ambulance.jpg]

In the Frostburg Historical District, the Frostburg Ambulance demonstrates most of these principles or the lack of the application of these principles. The building has a lower height than the other buildings. It has a height to width proportion similar to the home on the right in figure 14.22. It has a greater setback than the other houses on the block. In addition, its construction is different than the other buildings on the block. The building looks out-of-place and inconsistent with its surrounding buildings.

Applying the same principles to Frostburg Ambulance (see figure 14.22), the front of the building could be designed to complement the other building in the neighborhood. They could still have their multi-bay garages on the back of the building for their ambulances, hidden from sight of mainstreet.

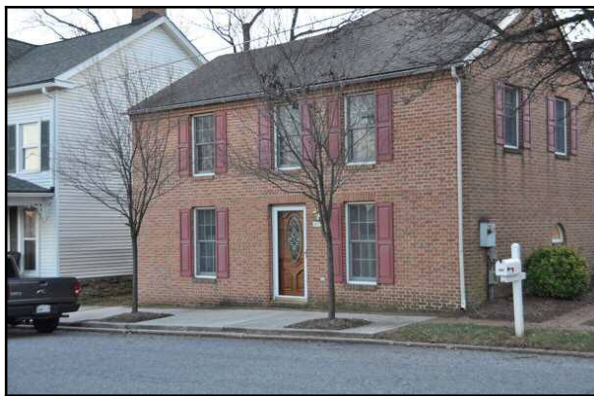
**Figure 14.23 – House in Burkittsville (front)** – Caption: Located in a historic district, the front of the homes conforms to height, proportion, and setback rules. Also, note that the brickwork is a Flemish Bond. – Source: Author [file:\fig1323-Burkittsville016.JPG]

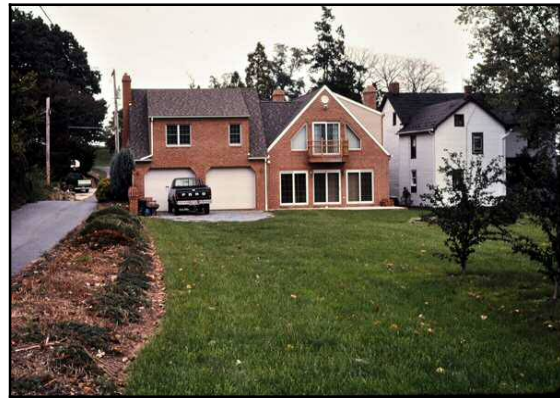
**Figure 14.24 – House in Burkittsville (rear)** – Caption: The rear of the same house in Burkittsville. People are allowed non-conforming designs. It is a compromise between maintaining historical integrity and modern designs and convenience. – Source: author [file:\fig1324-Burkittsville003.JPG]

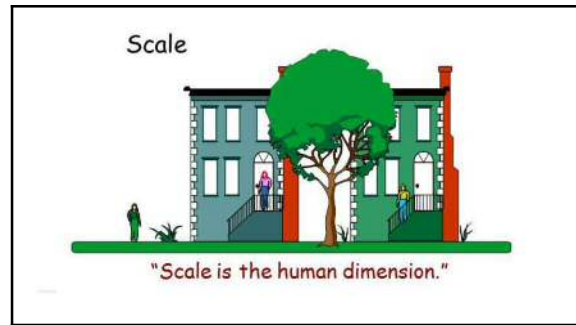
**Figure 14.25 – Scale** – Caption: Scale is the human dimension. It is provided by doors, steps, railings, trash cans other elements with which people can determine dimensions in terms of humans. – Source: Author [file:\fig1325-Scale.jpg]

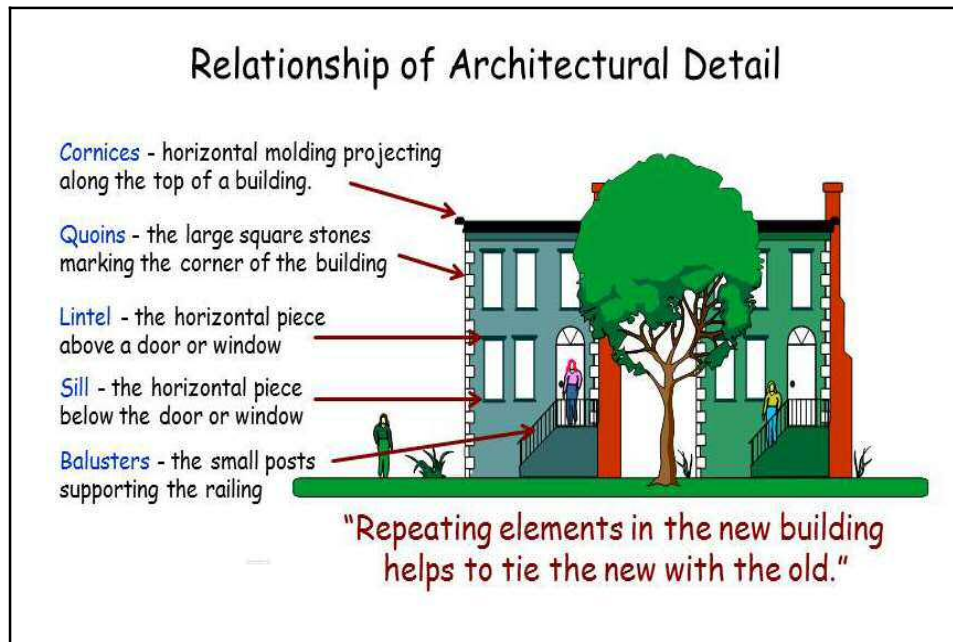
**Figure 14.26 – Architectural detail** – Caption: Several of the architectural details found in buildings are identified in the graphic. – Source: Author [file:\fig1326-ArchitecturalDetails.jpg]

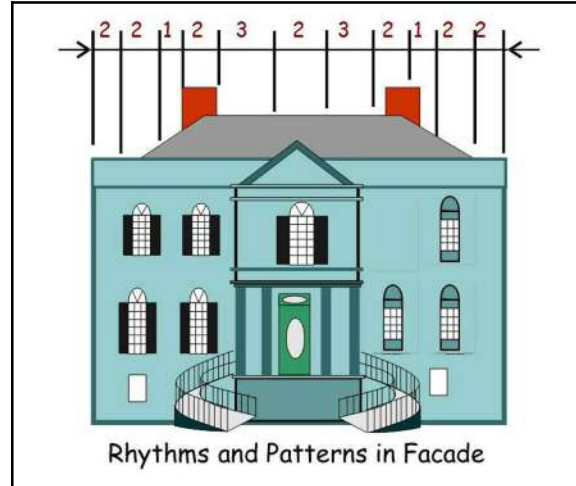
**Figure 14.27 – Rhythm and pattern in facade** – Caption: This facade shows both proper spacing (left side) and improper rhythm (right side). One of the windows on the right was “blocked in” disrupting the rhythm of the facade. Also, one of the windows on the right side was replaced with a smaller window and blocked down. – Source: Author [file:\fig1327-Facade.jpg]

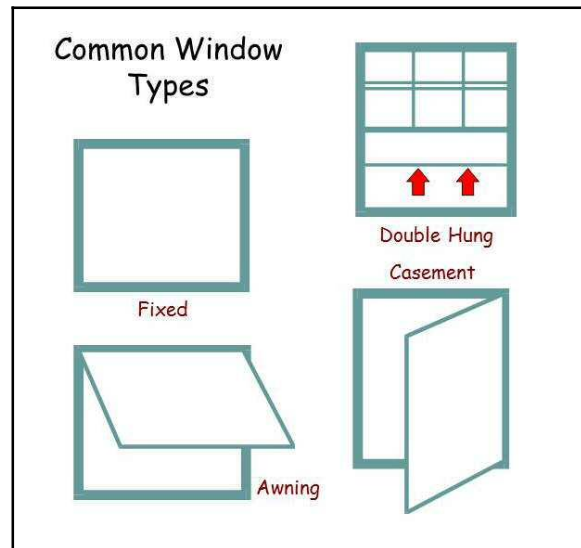
**Figure 14.28 – Types of Windows** – Caption: Four common types of windows are depicted. As it named implies, the fixed window is fixed and doesn’t open. Casement windows are hinged on the side and open sideways. Awning windows open upward. Most people are familiar with the double-hung window where the bottom section of the window slides upward to open the window. – Source: author [file:\fig1328-WindowTypes.jpg]

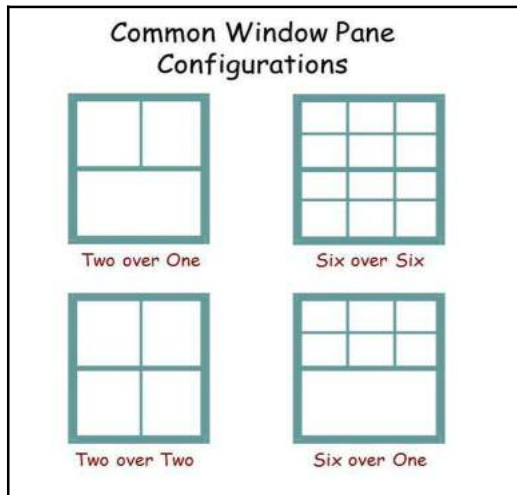
**Figure 14.29 – Window Pane Configuration** – Caption: This graphic shows several different window pane configurations. These refer to the number of panes in the above window and the number of panes in the lower window of a double hung window. Also, they can refer to the over and below count on a fixed window simulation or other type of window. – Source: author [file:\fig1329-WindowPaneConfig.jpg]

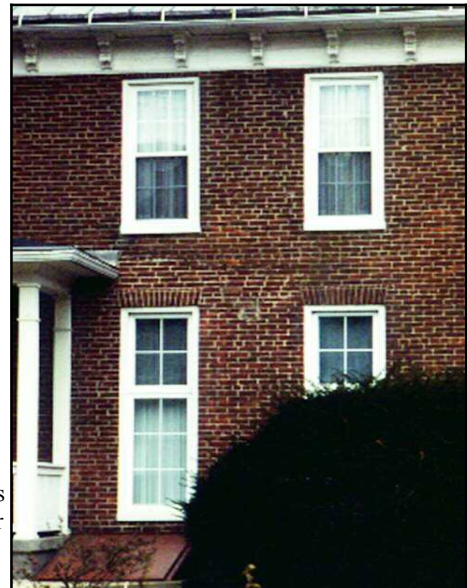
**Figure 14.30 – Windows Pane Configuration Example** – Caption: This building utilizes two different window configurations. The first floor is a four over six configuration and the second floor is a four over four configuration. – Source: author [file:\fig1327-WindowPaneConfig[2].jpg]

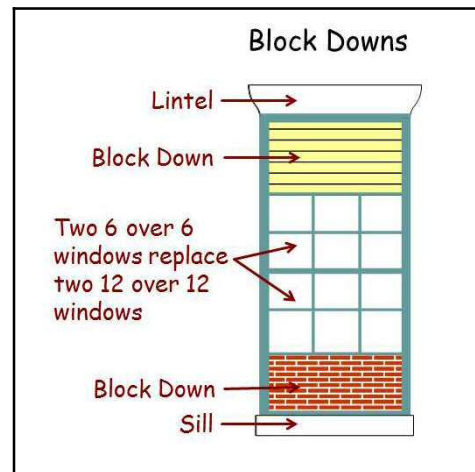
**Figure 14.31 – Block downs** – Caption: Older buildings generally had large windows to provide ambient light. Usually replacement windows are smaller or don’t utilize the same dimensions. In order to replace the old windows at a moderate cost, the windows are blocked down – Source: author [file:\fig1331-BlockDown[1].jpg]

**Block downs** – Standard window dimensions change. In addition, replacement windows for the large windows found in older buildings are expensive. Often it is more cost efficient to replace the windows with smaller windows that conform to standardized dimensions. The issue becomes one of making the new window fit in the frame of the old window well. The process of filling in the top below the original lintel and below above the sill is called “block down” (figure 14.31). Two examples are provided (figure 14.32 and figure 14.33).

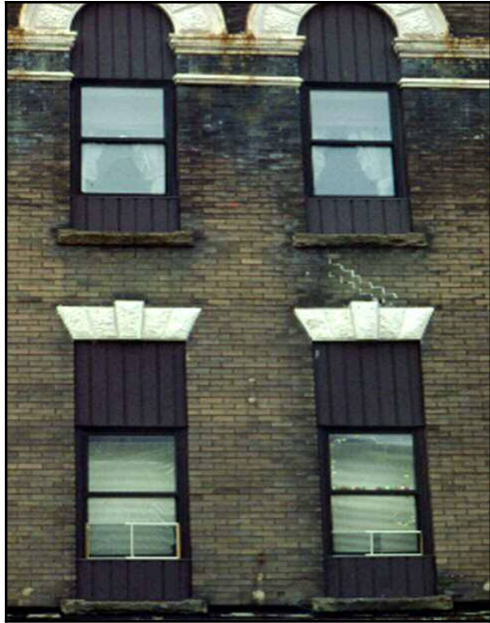
**Figure 14.32 – Windows** – This figure shows a typical block down where the original window was filled in above and below the replacement window. – Source: author [file:\fig1332-BlockDown[2].jpg]

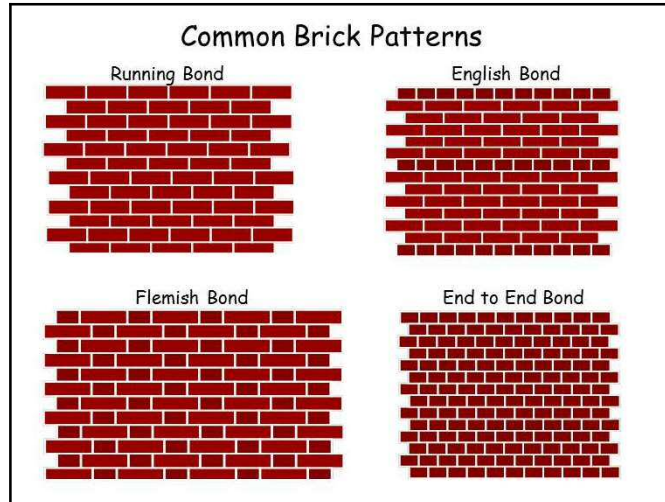
**Figure 14.35 – Brick Work** – Caption: Brick patterns provide interest and historical authenticity to the brick walls. This diagram provides four common examples. – Source: author [file:\fig1335-BrickPatterns.jpg]

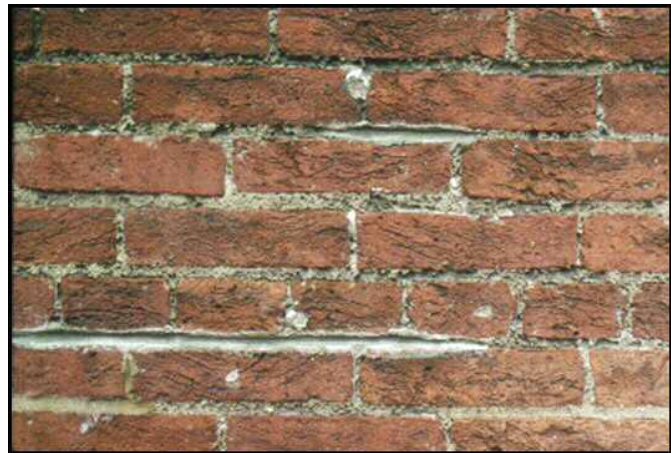
**Figure 14.36 – Sandblasting** – Caption: This brick wall was sandblasted. The smooth finish of the mortar has been removed leaving a coarse and porous mortar. Contrast this with the sections that were touched up. They are smooth. Also, the third row of bricks from the bottom suggests the use of an English Bond (the ends are facing outward). – Source: author [file:\fig1333-Sandblasting.jpg]

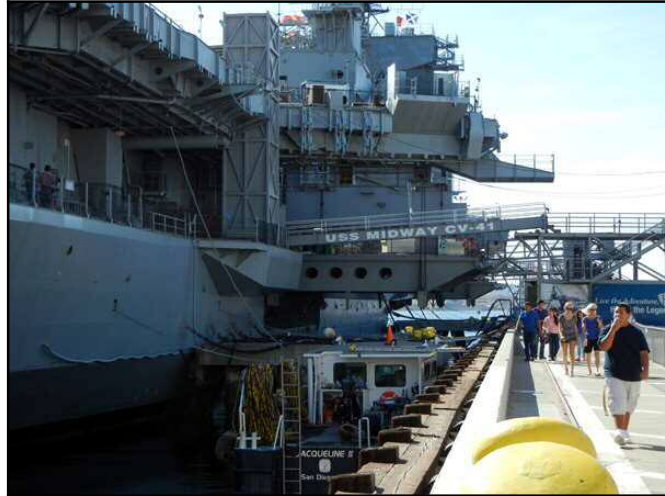
**Figure 14.39 – USS Midway** – Caption: Historic preservation comes in many forms. The USS Midway is anchored permanently in San Diego harbor. There are many issues that need to be addressed including accessibility. The ship was built for war and not the general public. San Diego, California. – Source: author [file:\fig1335-DSCN0558.jpg]

Often, the item being preserved was built for a different purpose and needs to be converted before it can be used by the general public. The USS Midway is a decommissioned WWII aircraft carrier permanently anchored in San Diego Harbor (figure 14.39). It was decommissioned in 1992 and converted into a floating museum of aviation history that opened in 2004. Warships are built for war and not the general public (figure 14.40). Even on a large ship like the USS Midway, space is at a premium. Stairwells are steep and narrow. Hallways are narrow, and doorways require step overs.

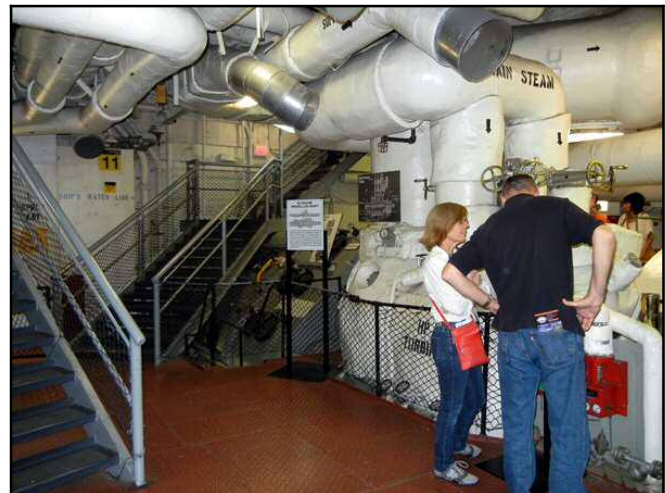
**Figure 14.40 – USS Midway Stairway** – Caption: Converting historic facilities that are designed for a different purpose can be expensive and difficult to install. The stairway in the back of one of the engine rooms in the USS Midway was added to provide access by the general public. USS Midway, San Diego, California. – Source: author [file:\fig1336-DSCN0557.jpg]

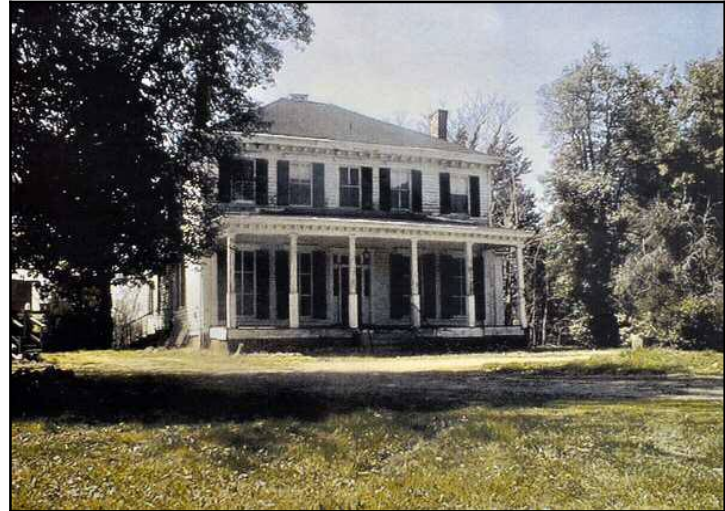
**Figure 14.41 – Chelsea** – Caption: Chelsea was a tobacco farm in Prince George's County. Although it provides an excellent resource that explains the cultural history of the region, it also reminds the community of past race relations. Some preferred a solution by the fire department. Fortunately, the facility is being rehabilitated as part of the cultural heritage of the county. – Source: Author [file:\fig1337-Chelsea001.JPG]

The photo in figure 14.41 was taken in 1999 before any stabilization or restoration work. Estimates at that time suggested \$100,000 just to stabilize the building. Inspect the chimney, the porch and other features of the building. Nothing is at right angles to anything else. The photo in figure 14.42 was taken in 2013 while the building was undergoing restoration. Reexamine the chimney, porch and roof. They are no longer in disrepair. Note that the windows were boarded over to increase the security of the building and to reduce the likelihood of vandals breaking them during the rehabilitation process.

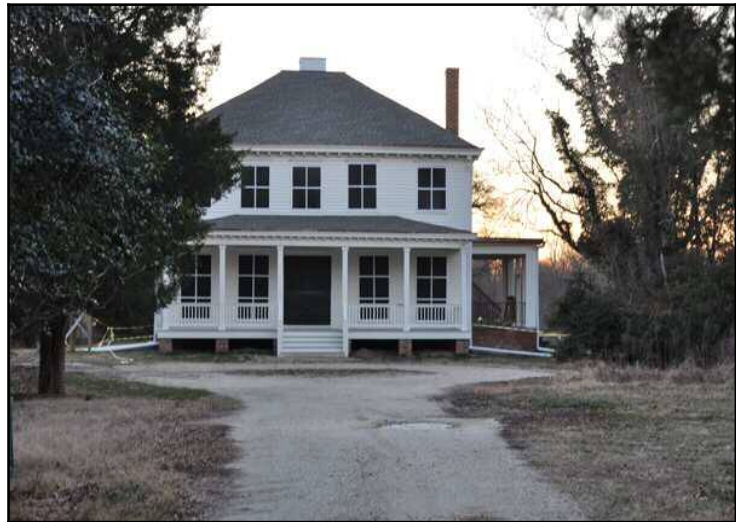
**Figure 14.42 – Chelsea** – Caption: Chelsea was a tobacco farm in Prince George's County. Although it provides an excellent resource that explains the cultural history of the region, it also reminds the community of past race relations. Some preferred a solution by the fire department. Fortunately, the facility is being rehabilitated as part of the cultural heritage of the county. – Source: Author [file:\fig1338-Chelsea009.JPG]

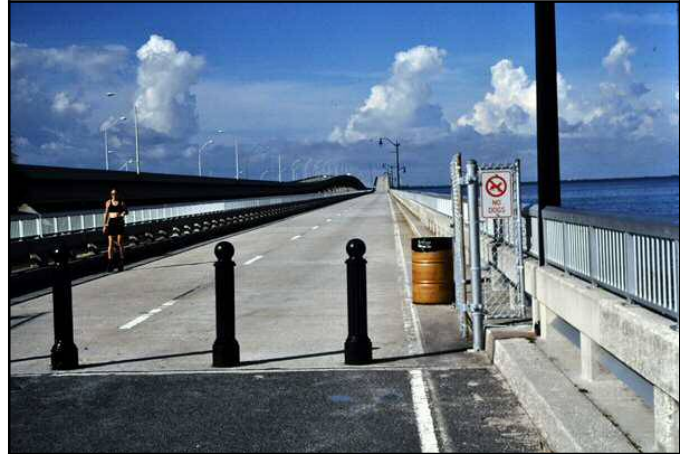
**Figure 14.43 – Friendship Bridge** – Caption: Just because it is old, doesn’t make a facility historically significant. Friendship Bridge lacked historical significance and was an economic burden to the local recreation and parks department that was responsible for maintaining it. The new bridge is adjacent to this bridge on the left. Tampa, Florida. – Source: author [file:\fig1339-DSC\_0923.jpg]

Friendship Bridge or the “old Gandy Bridge” is a 2.6 mile long bridge across Tampa Bay between Pinellas (Tampa) and Hillsborough counties (figure 14.43). In 1997, the bridge was replaced with a new bridge. As part of the construction, funds were originally budgeted and available to demolish the old bridge. A friends group organized and saved the bridge from being demolished. Because of their efforts, the parks and recreation department became responsible for managing the bridge.

In 2002, the Department of Transportation (DOT) estimated maintenance of \$300,000 per year. The corrosive effects of saltwater continued to take its toll on the bridge. Salt corrosion was a reason for needing to replace the bridge. In addition, the park and recreation department estimated basic

From a recreational perspective, the bridge has marginal benefit. It is a destination attraction. Users need to drive to the bridge to use it. Nor did the bridge connect to trail systems on either end of the bridge. The result was that the bridge received limited use by bikers, inline skaters and fishermen. In addition, the bridge resulted in one fatality. A roller blader fell over backwards on the hump, hit her head and died (Hillsborough Park and Recreation, 2002). Recreation use on the bridge is mute since salt deterioration to the bridged caused it closure to any use in 2008.

Second, there needs to be a significant revenue stream available to support the restoration, and the restoration needs to be viewed in terms of its opportunity costs. Refurbishing the bridge in 2012 was estimated to be between 10-15 million dollars (Ruth, D., 2012). As previously noted, its maintenance and operational costs were a significant drain on funds and on providing other more beneficial programs.

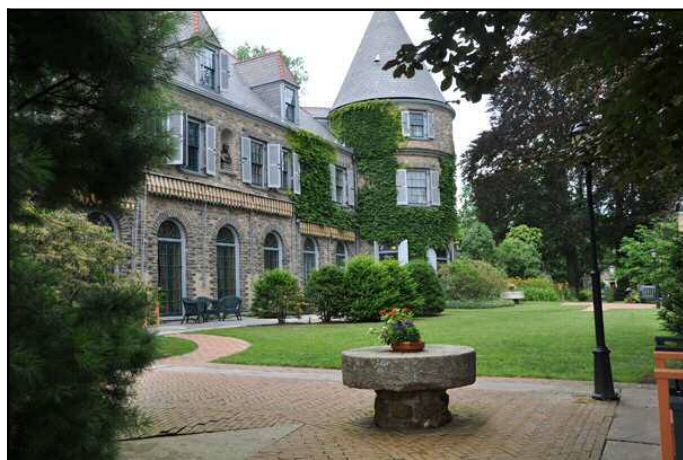
**Figure 14.45 – Grey Towers** – Caption: Grey Towers is historically significant. However, it was in a state of disrepair before funds were appropriated to rehabilitate it. Milford Pennsylvania. – Source: author [file:\fig1341-DSC\_0968.jpg]

Unfortunately, the house was in a state of general disrepair when it was received by the Forest Service. It had a leaky roof and suffered from water damage. Several of the interior walls suffered from water and insect damage. Originally, the USFS planned to use Grey Towers as a conference center. In addition, until funds were eventually appropriated for the restoration of the house, it remained in a state of disrepair. It should be noted that since Grey Towers was the Forest Service's first National Historic Landmark, it can be inferred that restoration of the building was a process with which they were unfamiliar. Eventually, appropriations were obtained and the house was restored. In addition, the Forest Service worked with the National Park Service at Harpers Ferry in the restoration of Grey Towers back to its historically significant state.
